**Re: Supplementary Slope Stability Assessment – Residential  
Development, 115 Rangers Road, Highland Grove, ON  
Cambium Reference: 02630592.000**

**SLOPE STABILITY**  
JUSTIN AND NICOLA FLOWERDAY  
115 Rangers Road  
Highland Grove, Ontario

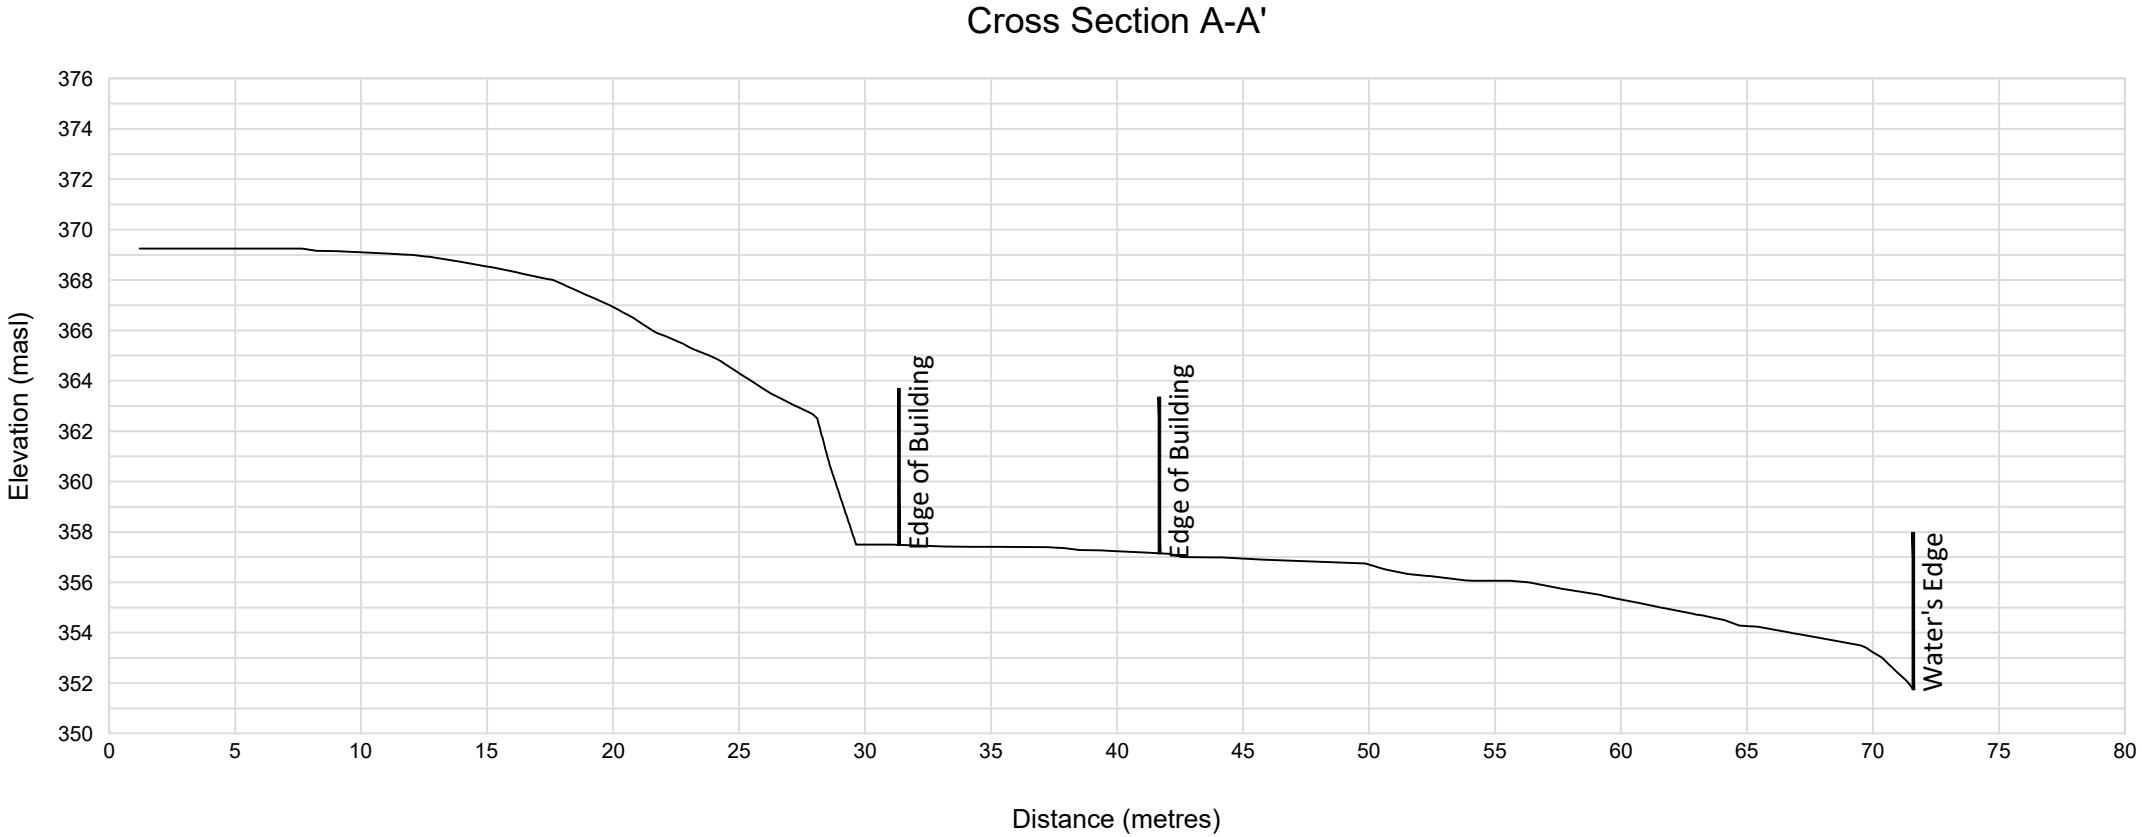
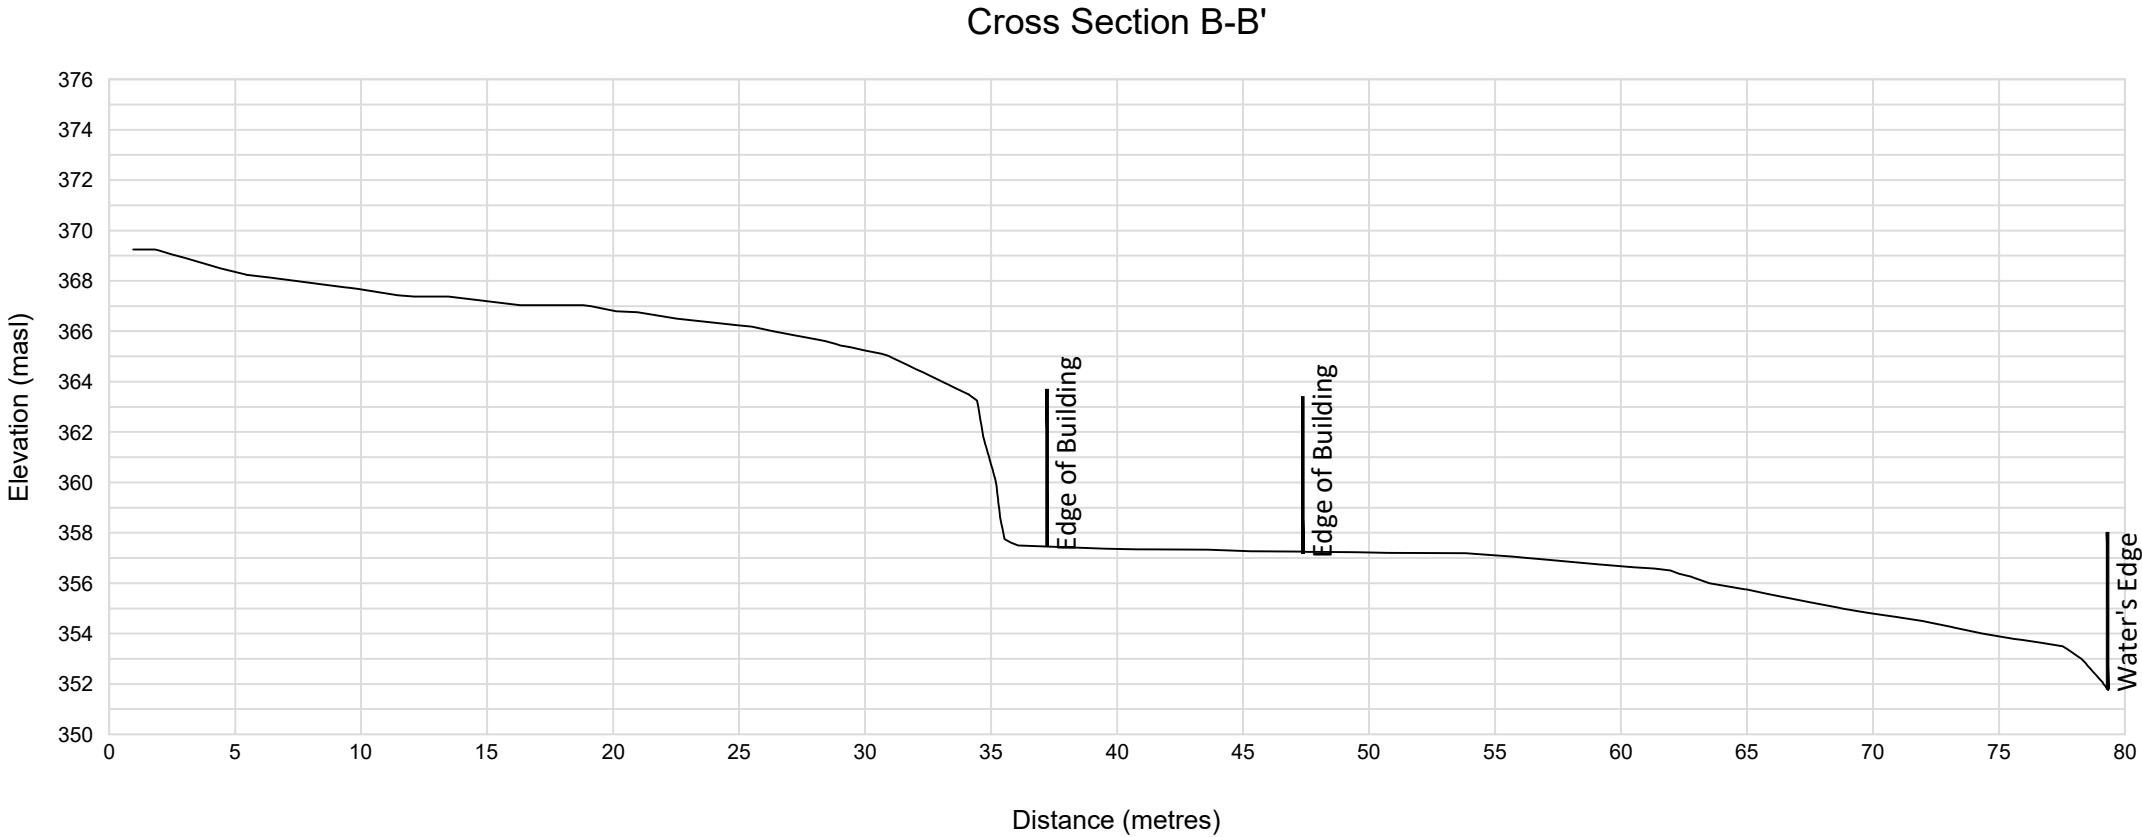
CROSS SECTIONS

Cambium was also provided with the CAD file for a topographic survey conducted by P.A. Miller Surveying Ltd., file name 26-12861. The data from the topographic survey was used to illustrate cross sections (as shown on Figure 3) of the altered existing slope for discussion.

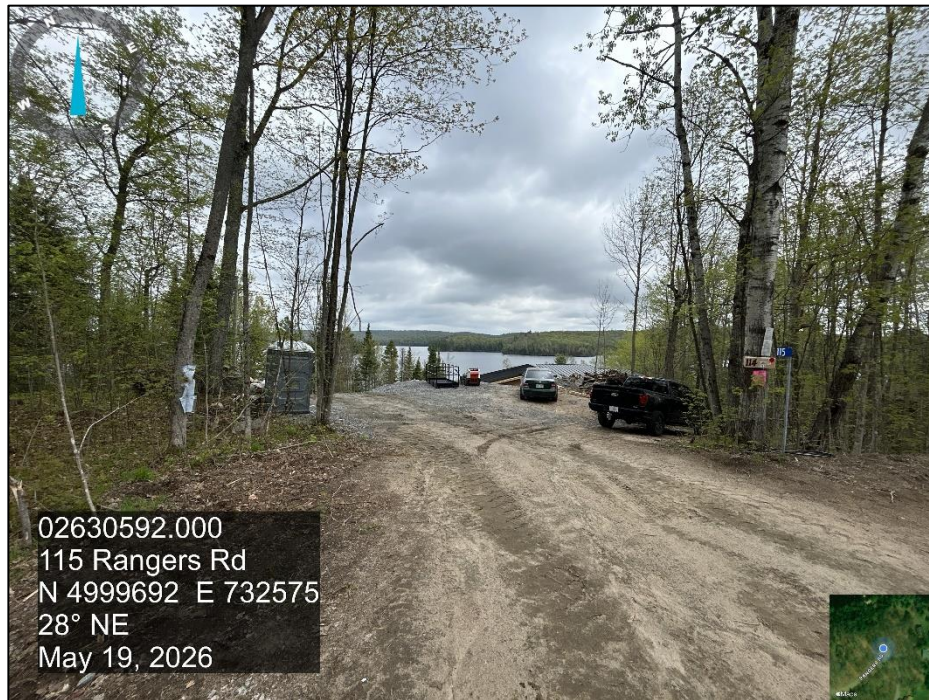
**Photo 1** Site overview, looking north, from Rangers Road, showing mixed mature trees across the top of the upper slope area.

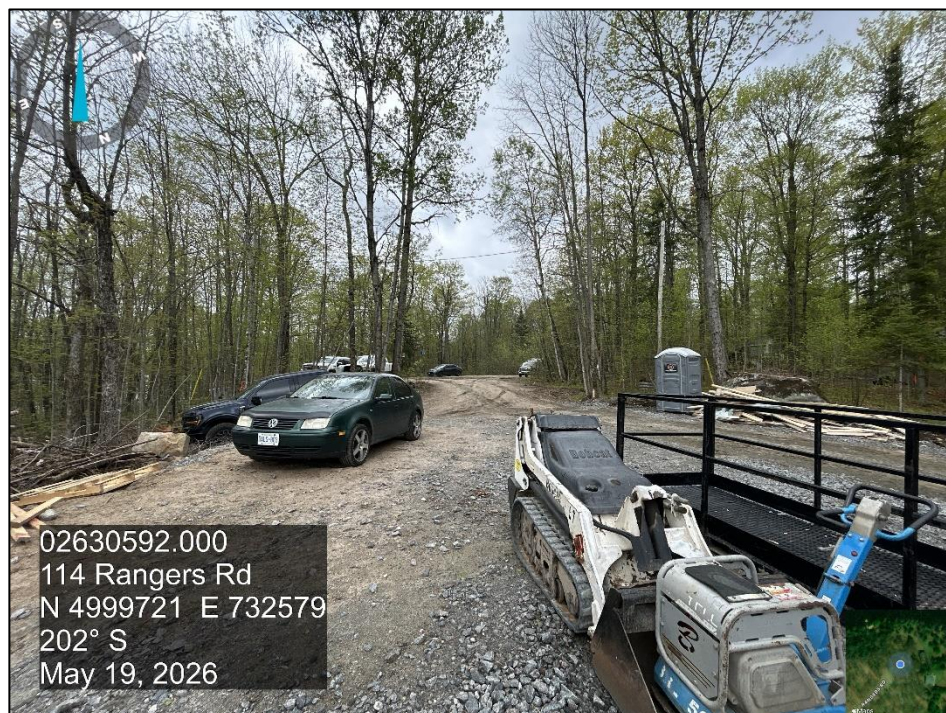
**Photo 2** View of the table land for the slope at the top of the upper slope area, looking west, showing mixed mature trees, and Rangers Road.

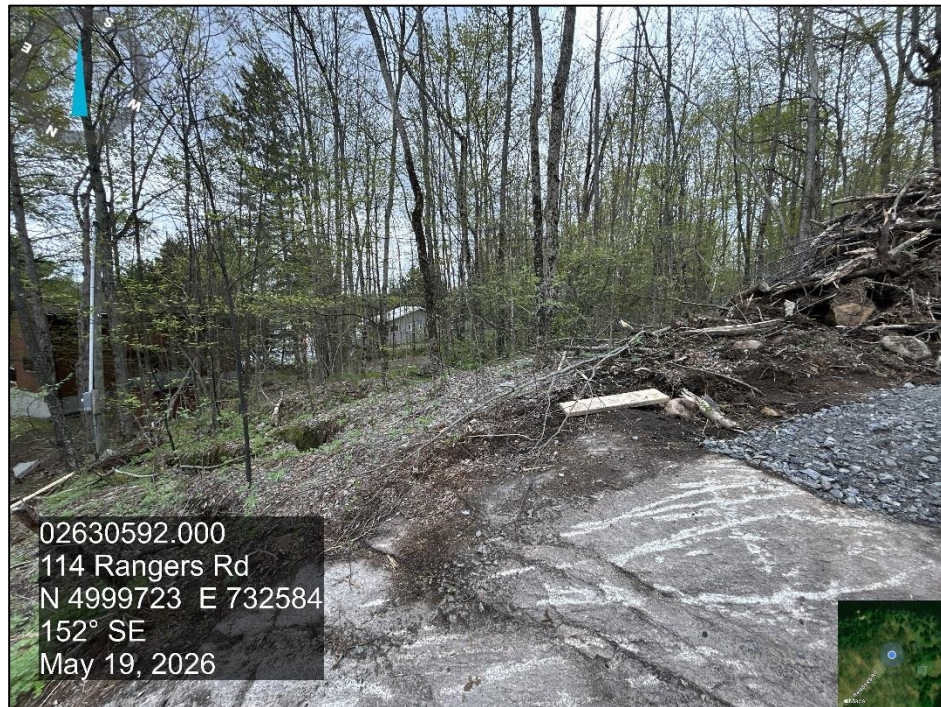
**Photo 3** View of top of the bedrock slope, looking east, showing granite and stockpiled construction debris and trees.

1. Stockpiled soil, rock, and construction materials should be kept back from the slope crest.
2. Loose rock fragments at the crest should be managed or removed as necessary to reduce potential rockfall risk.
3. Existing vegetation on the lower slope should be maintained where feasible.
4. Surface drainage should be directed away from the slope to prevent erosion.
5. No further steepening of the slope should be undertaken without geotechnical review.

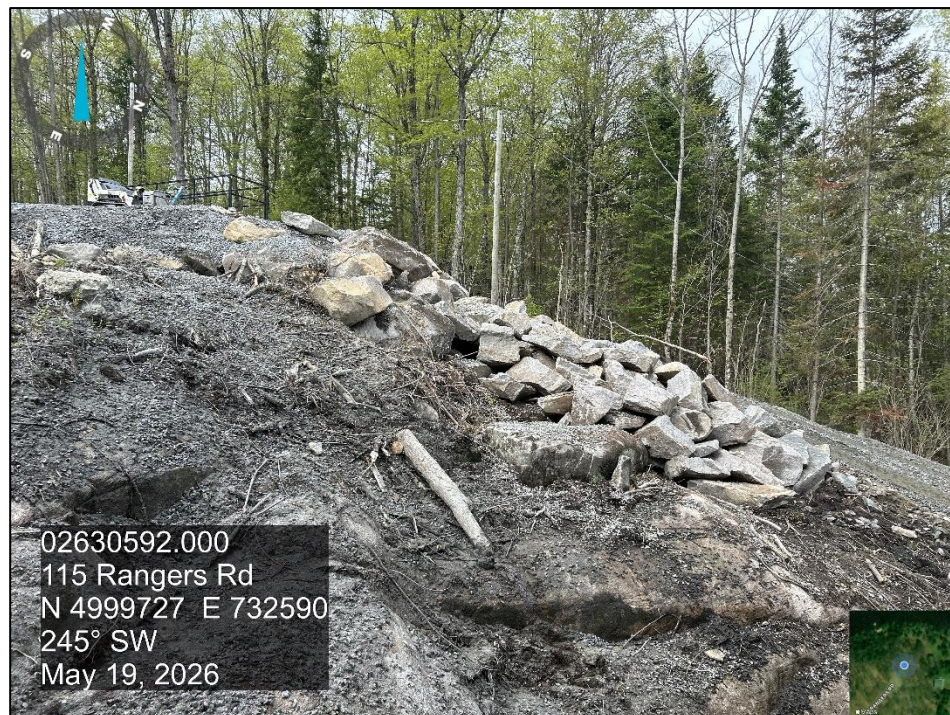
**Photo 4** View of top of the bedrock slope, looking west, showing granite and stockpiled boulders along the top of the slope.

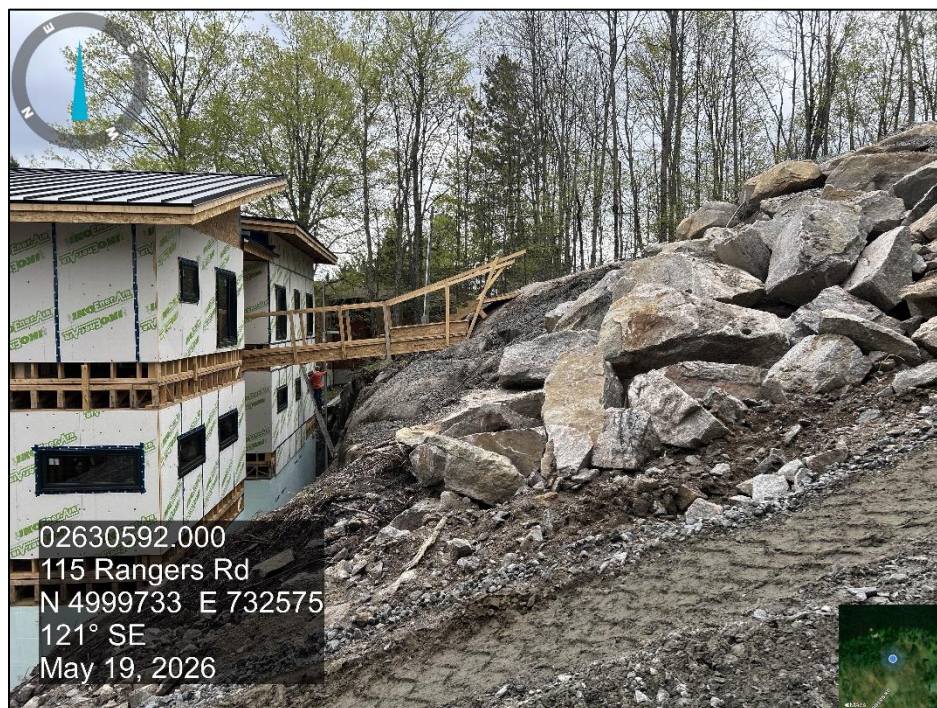
Loose boulders were observed along the top of the slope, due to placement after blasting of the bedrock. Cambium recommends that all loose boulders along the top of the slope and any along the slope face must be removed.

**Photo 5** View of the top of slope near the slope face, looking east, showing the residential structure under construction, exposed bedrock, and loose boulders along the top of the slope.

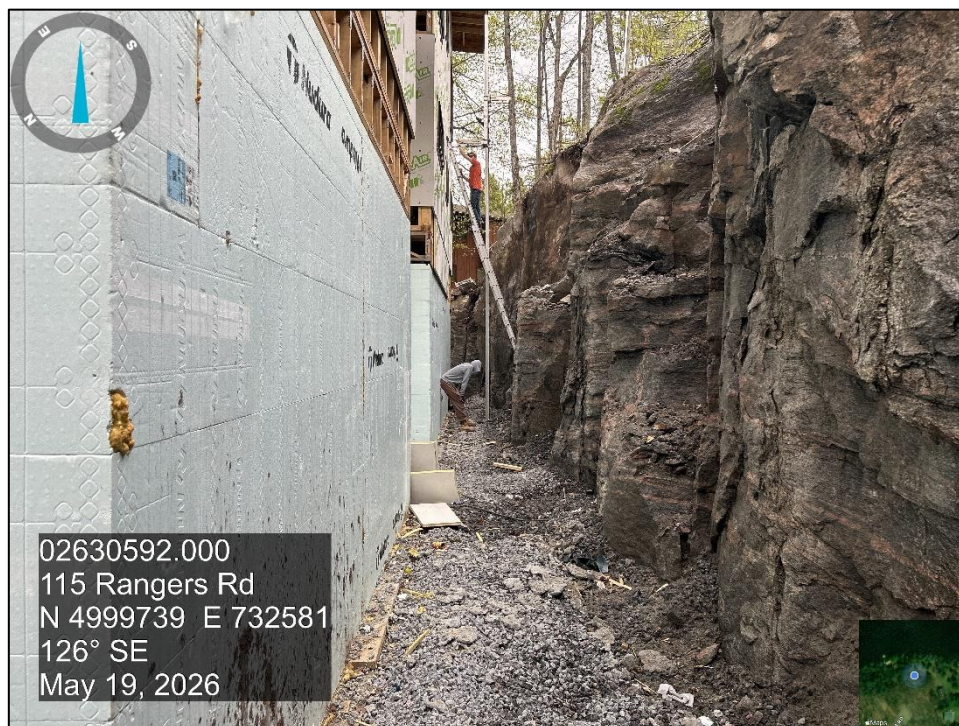
**Photo 6** View of the slope face, looking east, showing the residential structure under construction and exposed bedrock. The granite bedrock shows little to no significant joints or fractures. The slope face is approaching near vertical.

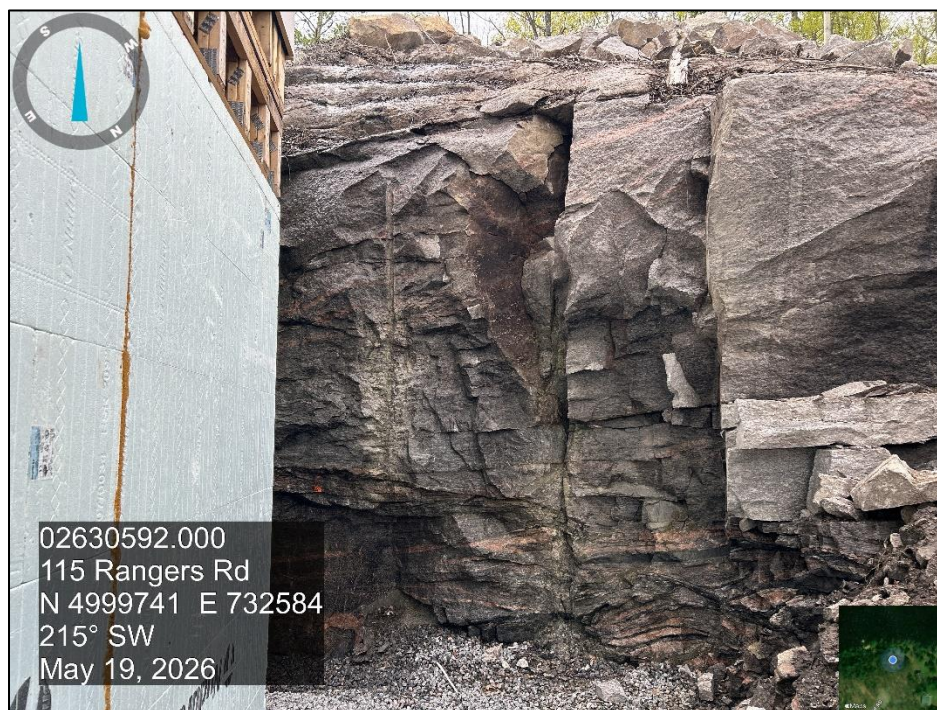
**Photo 7** View of the slope face, looking south, showing the residential structure under construction and exposed bedrock. The granite bedrock shows little to no significant joints or fractures. The slope face is approaching near vertical. Stockpiled boulders are evident along the top of the slope.

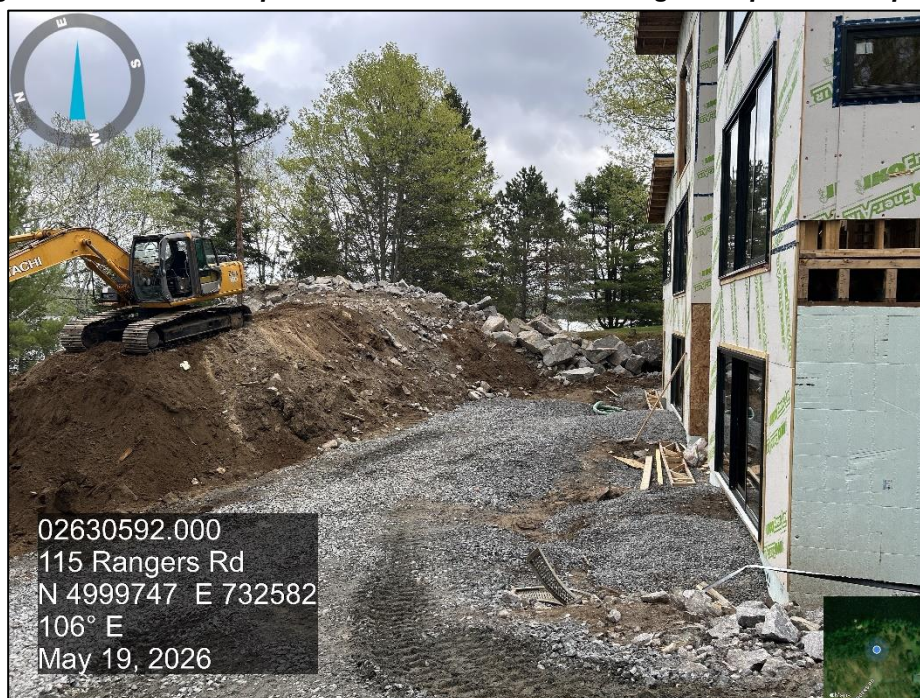
Additionally, a large stockpile of construction debris and boulders was observed above the shoreline. The Client was in the process of removing the stockpile at the time of the field investigation. Cambium recommends that the stockpile must be removed in its entirety.

**Photo 8** View of bottom of the slope, north of the residential structure under construction, looking east. Showing mixed mature trees along the shoreline and gravel over top of the bedrock. A large stockpile of construction debris and boulders is evident above the shoreline.

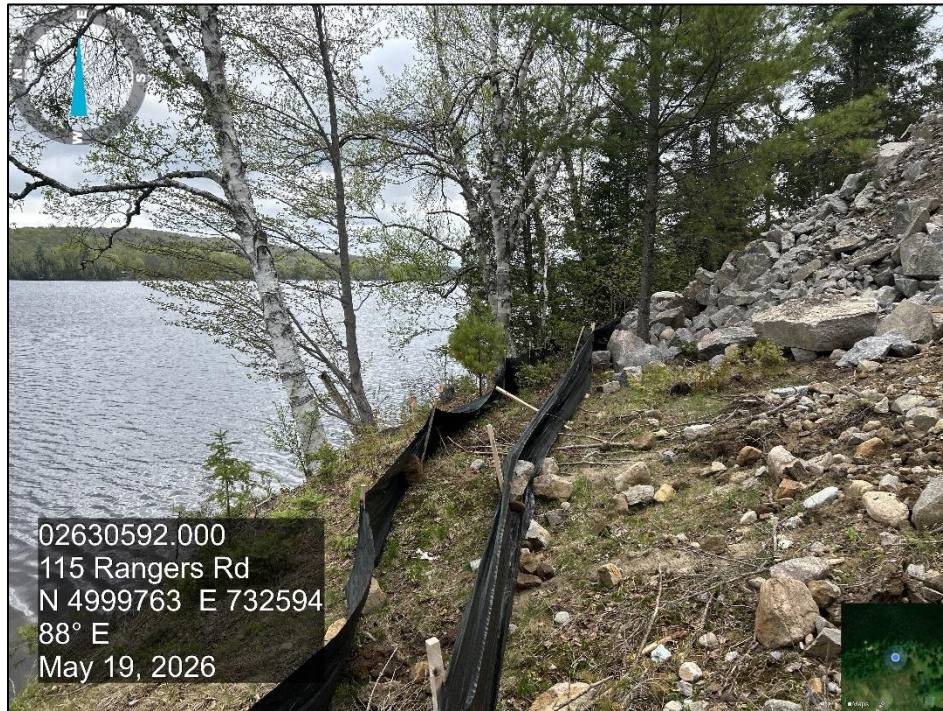
**Photo 9** View of the base of the slope, looking east, showing Baptiste Lake and mixed mature trees and boulders along the shoreline. A large stockpile of construction debris and boulders is evident above the shoreline.

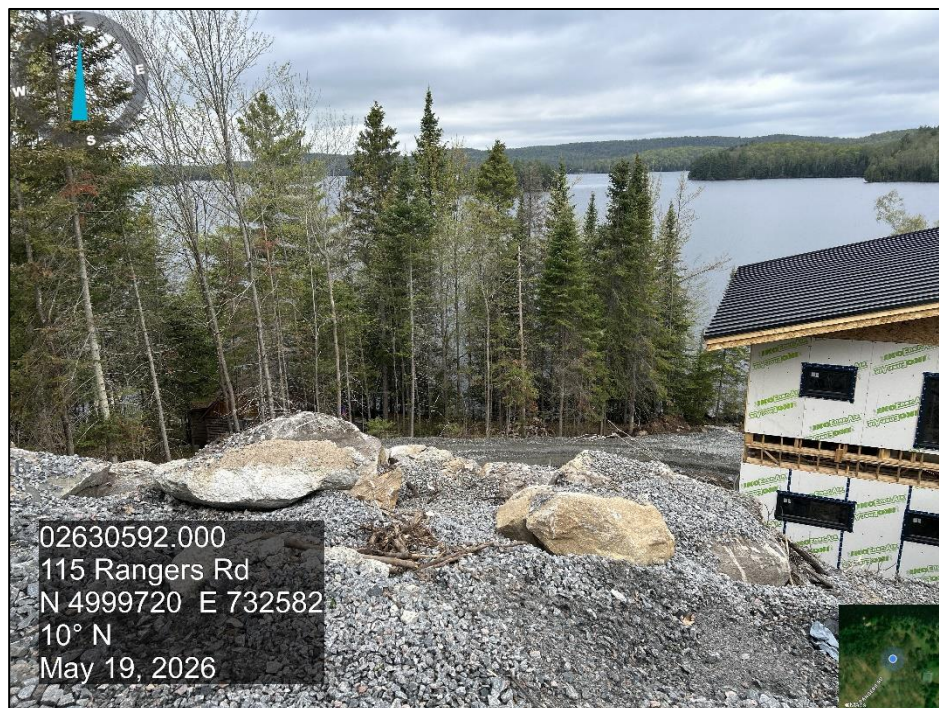
**Photo 10** Site overview, from the top of the slope looking north towards Baptiste Lake. Showing the residential structure under construction and boulders along the top of the slope.
