July 22, 2024

**Re: Slope Stability / Erosion Hazard Limit Assessment – Woodcox Road
Subdivision**

Cambium Reference: 11849-003

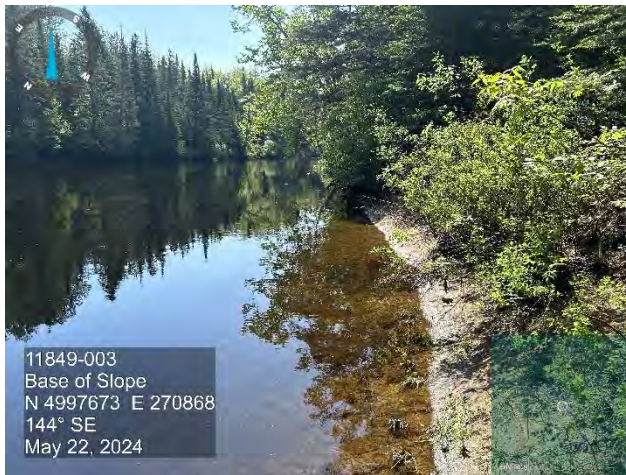
Photo 1: View of the bottom of slope, looking south, showing mixed mature coniferous and deciduous trees along the face and York River at base.

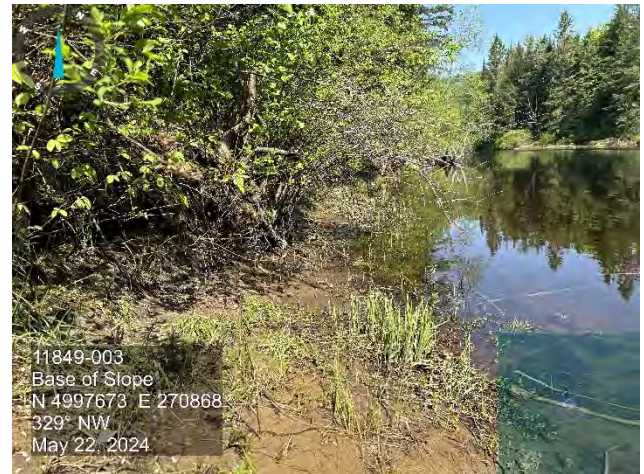
Photo 2: View of the bottom of slope, looking north, showing grasses and mixed mature coniferous and deciduous trees along the face and York River at base.

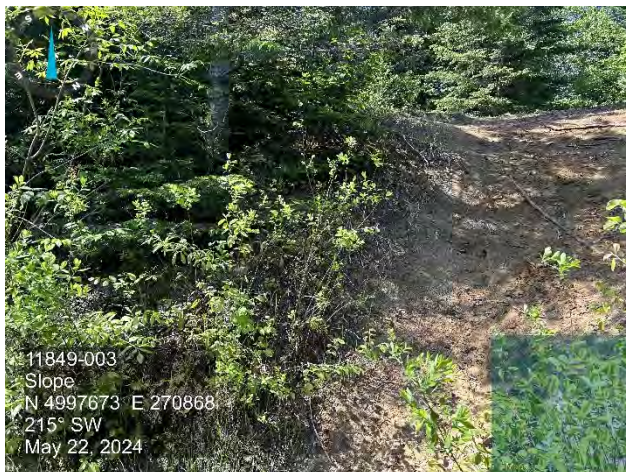
Photo 3: View of slope, looking west, showing from bottom to top. Light brown sand (medium-grained), some silt, trace gravel. Mixed mature coniferous and deciduous trees along the face.

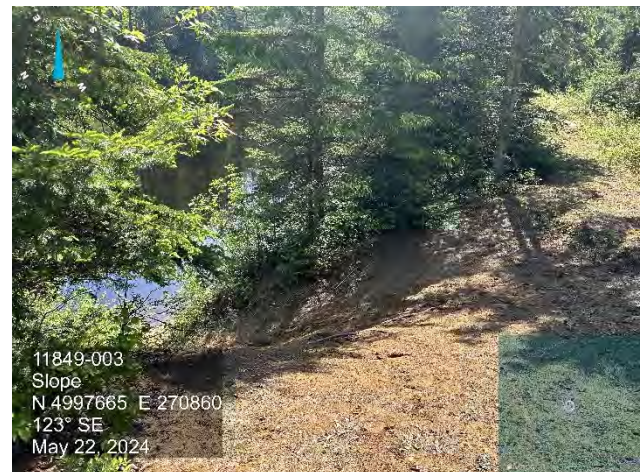
Photo 4: View of slope, looking east, showing from top to bottom. Light brown sand (medium-grained), some silt, trace gravel. Mixed mature coniferous and deciduous trees along the face, and York River at base.

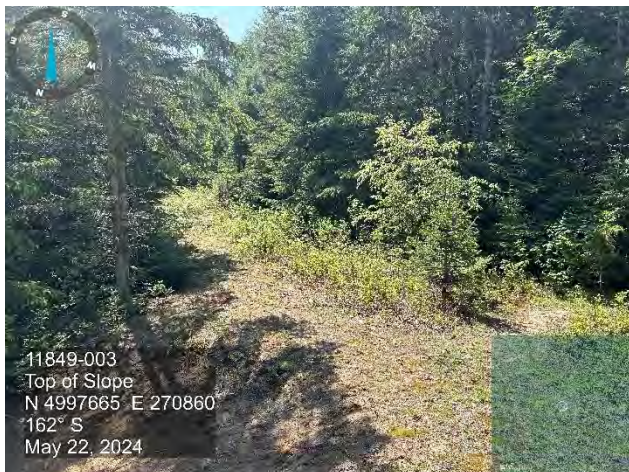
Photo 5: View of top of slope, looking south, showing grasses and mixed coniferous and deciduous trees.

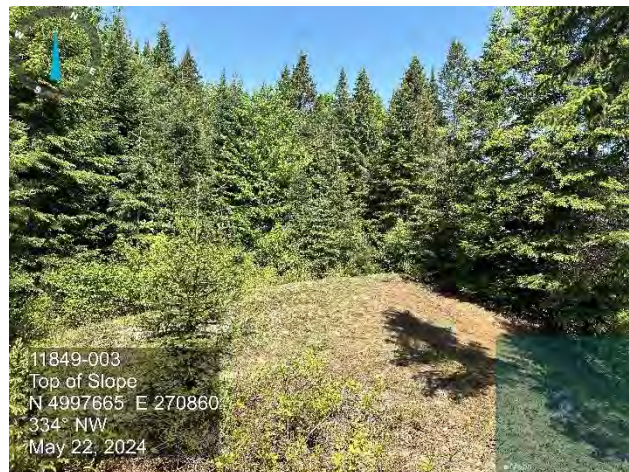
Photo 6: View of top of slope, looking north, showing grasses and mixed coniferous and deciduous trees.

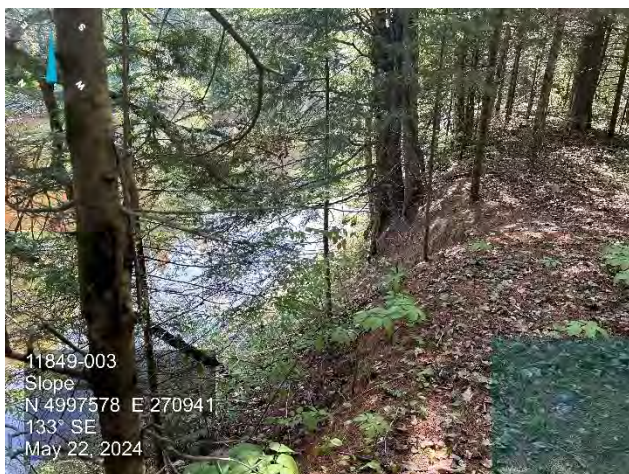
Photo 7: View of slope, looking south, showing the profile view of the slope. Mixed saplings and mature trees along the face of the slope and York River at the east of the slope.

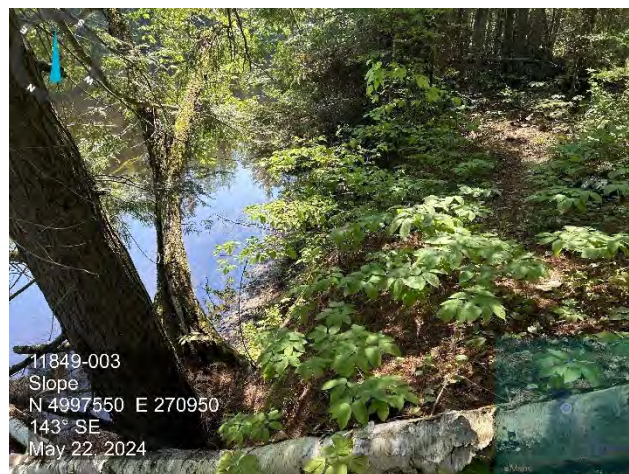
Photo 8: View of slope, looking further south, showing the profile view of the slope. Mixed saplings and mature trees along the face of the slope and York River at the east of the slope.

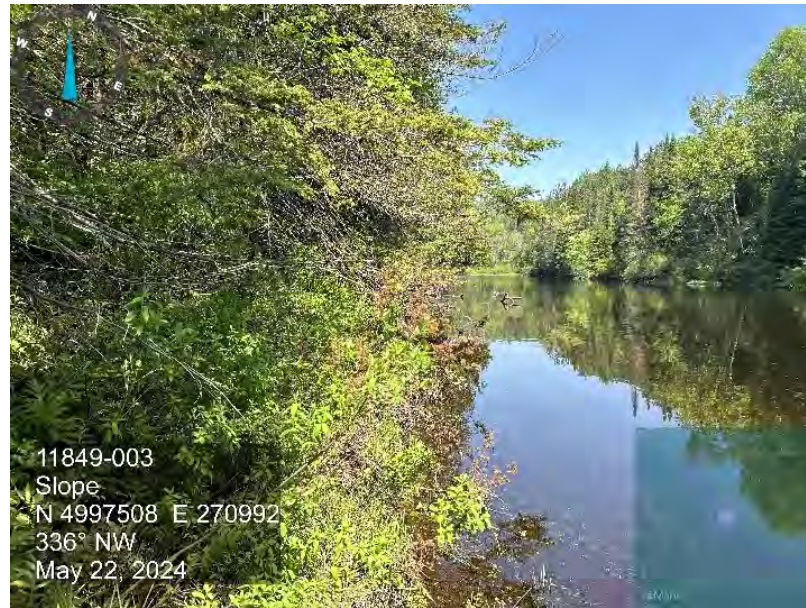
Photo 9: View of the bottom of slope, looking north from further south, showing mixed mature coniferous and deciduous trees along the face and York River at base.

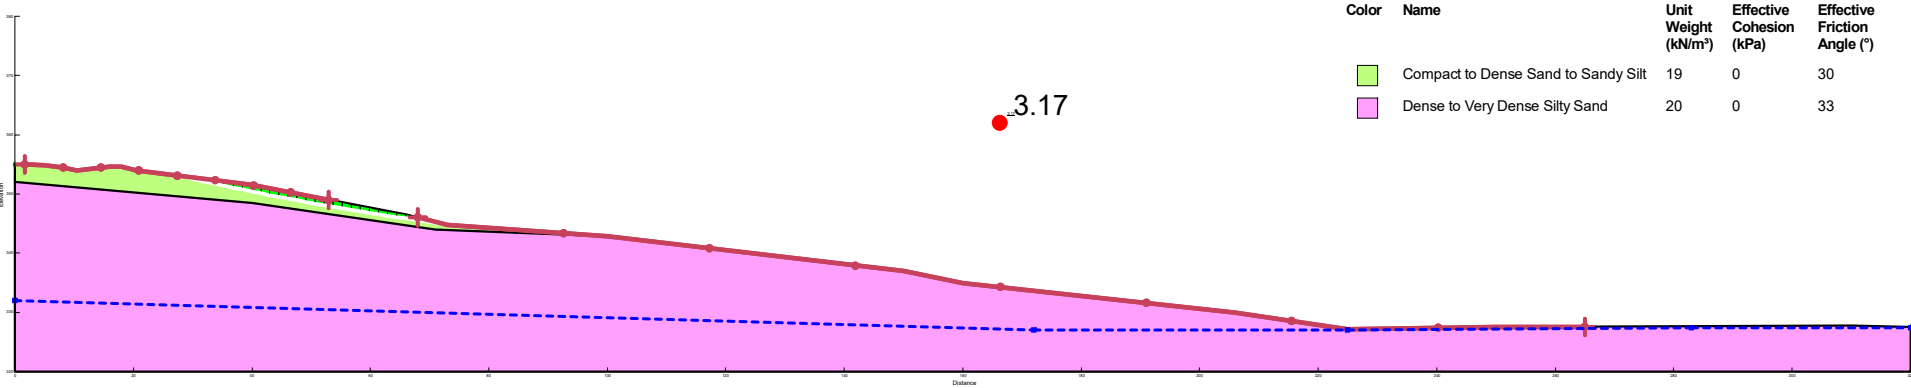
Section B-B Existing Conditions Upper Slope

Cross Section	Working Condition	Calculated Minimum Factor of Safety (FOS)
Section B-B	Existing – Normal Groundwater – Upper Slope	3.17
Section B-B	Existing – High Groundwater – Upper Slope	3.17
Section B-B	Existing – Normal Groundwater – Lower Slope	4.33
Section B-B	Existing – High Groundwater – Lower Slope	3.60

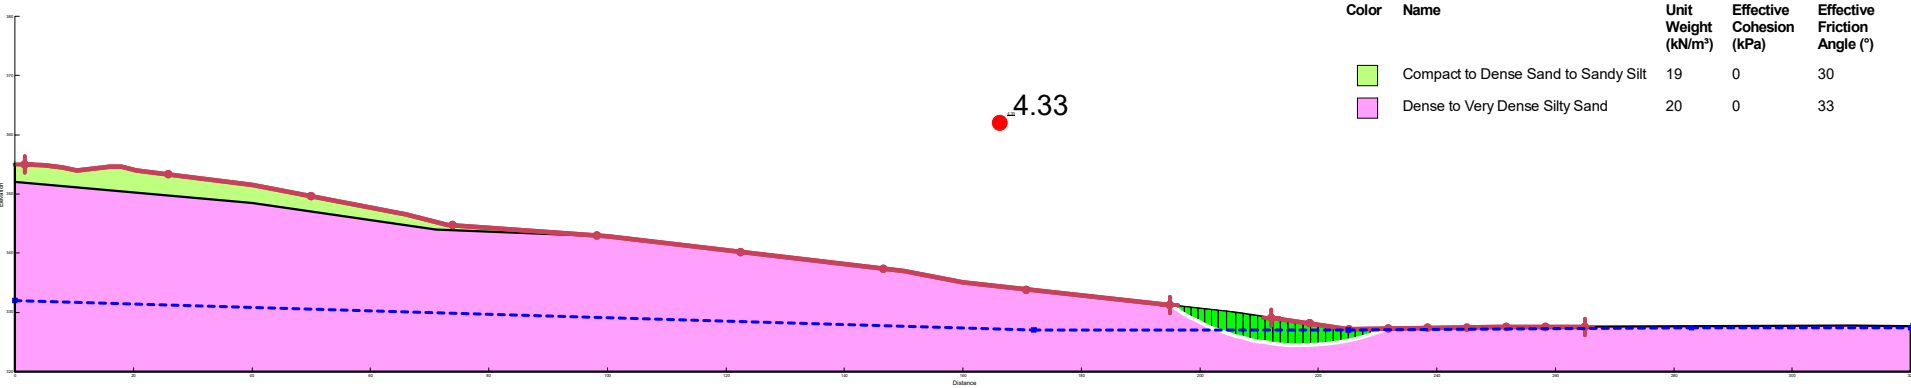
Section B-B Existing Conditions Lower Slope

For lower slope, the analysis results indicate a factor of safety (FOS) of 4.33 for normal groundwater condition and 3.60 for high groundwater condition. The change of groundwater would not affect the upper slope. For the analytical method employed, a FOS of 1.5 is typically appropriate or long-term stability with respect to the industry standards as well as *MNR technical guidelines*. FOSs of the existing slope are much higher than required FOS of 1.5.
