**Re: Slope Stability Assessment – Proposed Residential Redevelopment,  
439 West Diamond Lake Road, Highland Grove, ON**  
**Cambium Reference: 22031-001**

**SLOPE STABILITY  
ASSESSMENT**  
LINDSAY DESIGN  
439 West Diamond Lake Road  
Highland Grove, Ontario

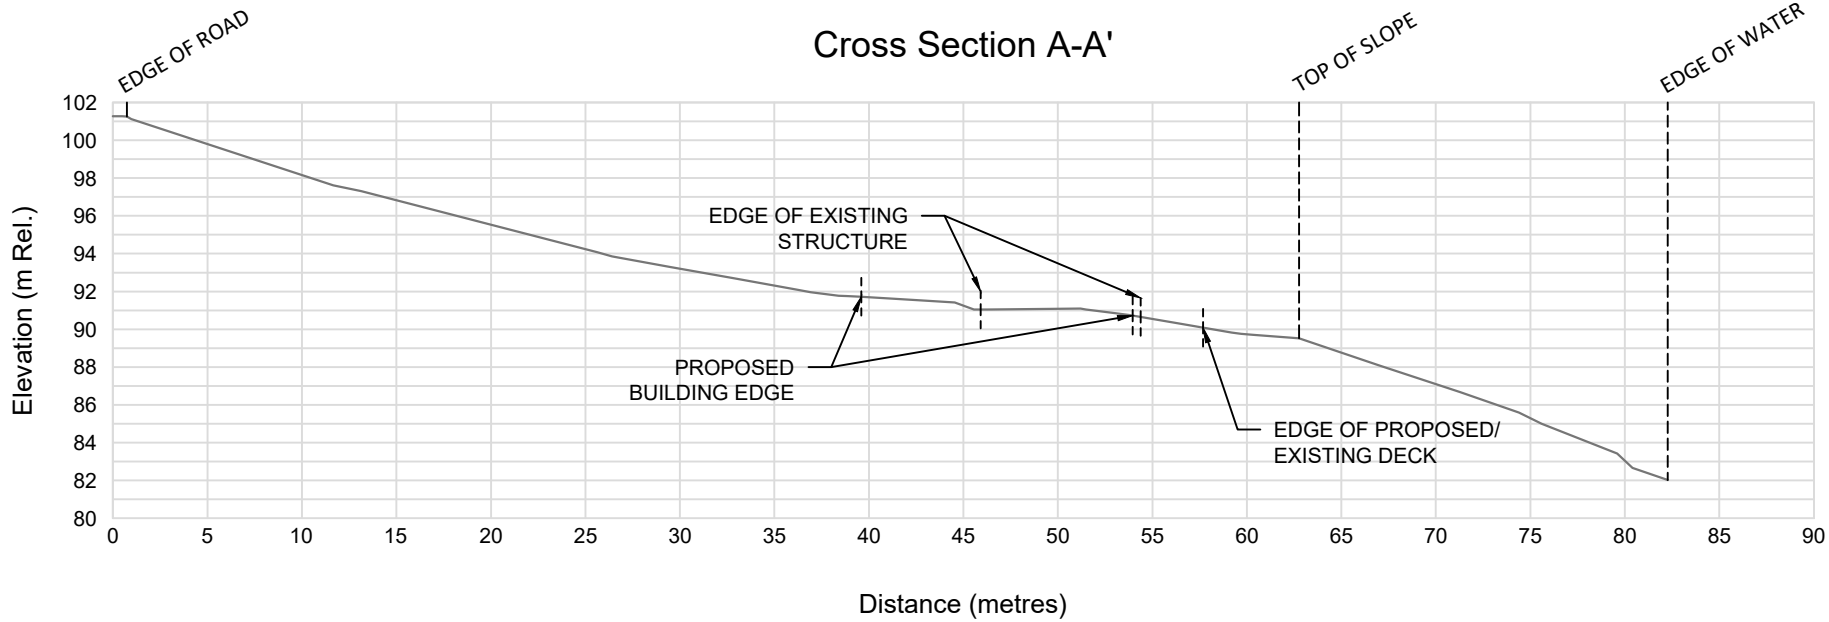
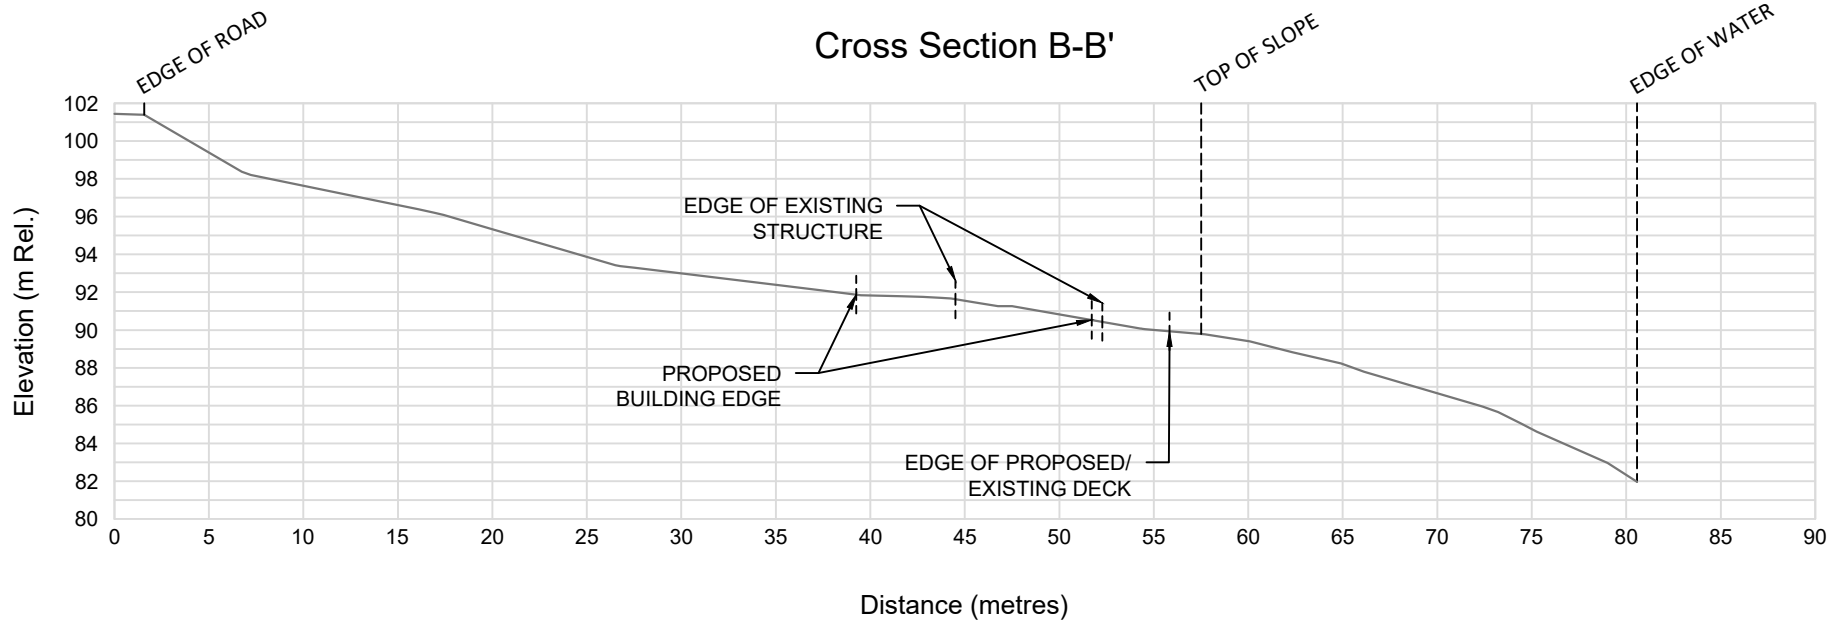
CROSS SECTIONS  
A-A' AND B-B'

Cambium also conducted a limited slope survey by using a Real-Time Kinematic (RTK) survey equipment, to illustrate cross sections (as shown on Figure 3) of the existing slope for discussion.

The steepest slope of 2.5H:1V is considered stable in its current condition. Therefore, the long-term stable top of the slope can be considered as the top of the existing slope, provided no structures will be developed closer to the slope crest than the existing structures on site. Based on information provided by the Client, the proposed building will be built no closer to the top of the slope as the existing structure, with new construction extending away from the slope.

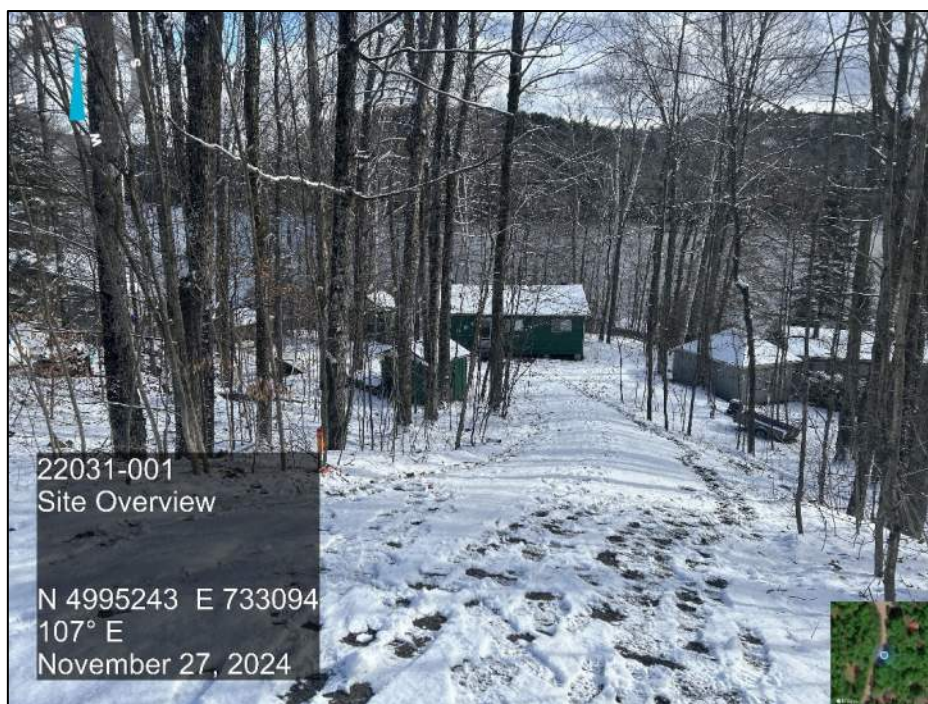
**Photo 1** Site overview, looking east from West Diamond Lake Road, showing a residential building, shed, and small building at the top of the investigated slope. Steep decline down the driveway to the residential building. Mixed mature trees are seen across the site. Cross section A-A taken along the south side of the residential structure, Cross section B-B taken along the north side of the residential structure.

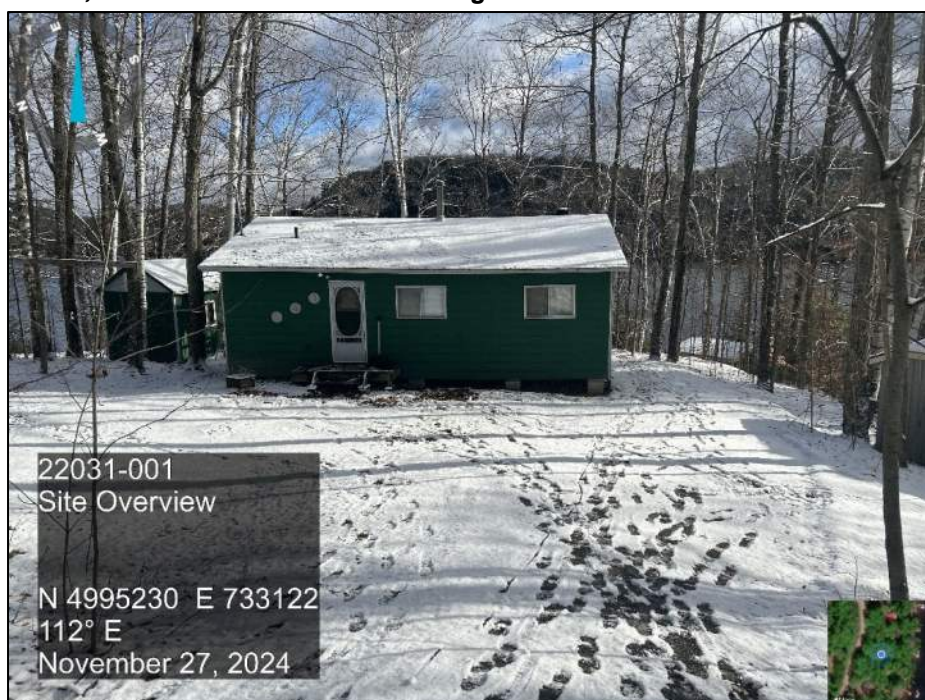
**Photo 2** Site overview, looking east, showing a residential building and small building at the top of the slope and mixed mature trees.

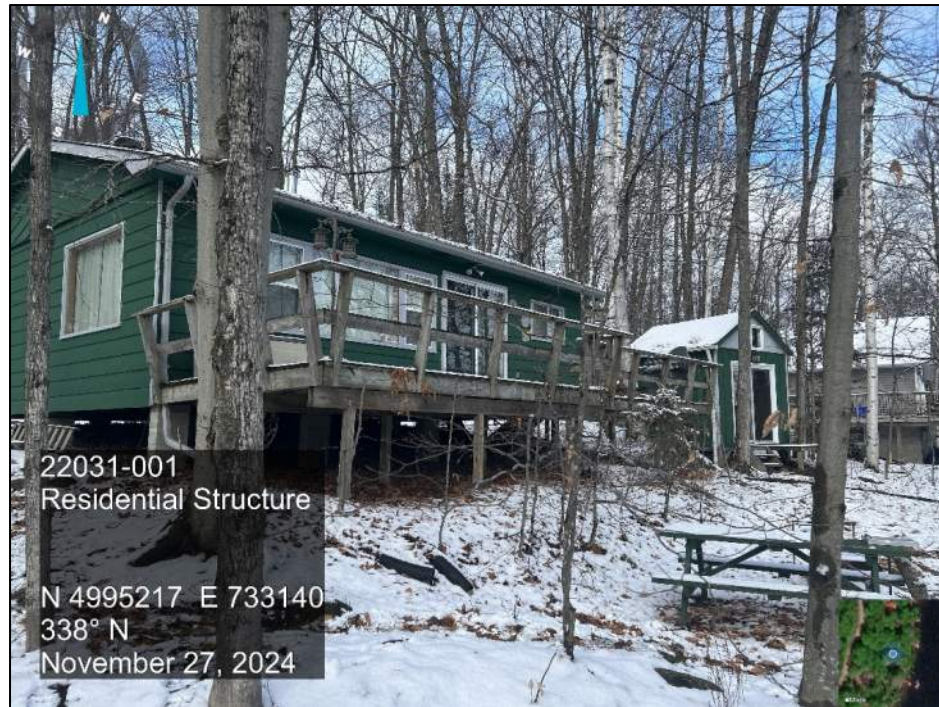
**Photo 3** Site overview, looking northwest, showing a residential building and small building at the top of the slope and mixed mature trees.

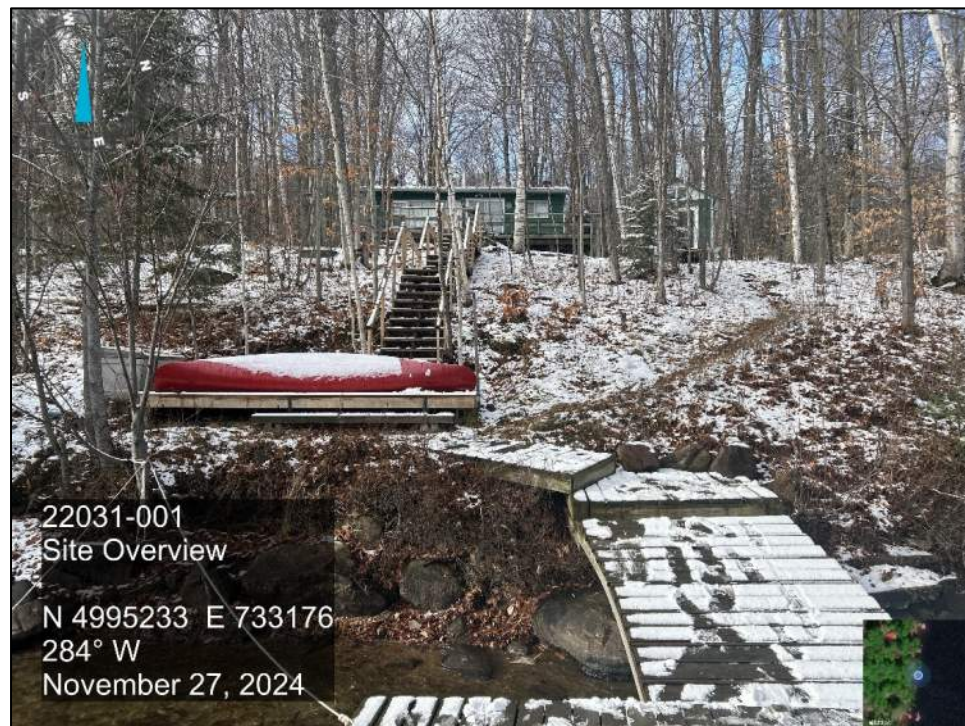
**Photo 4** Site overview, looking west, from the dock, showing a residential building at the top of slope, staircase along the slope, dock along the base of slope, and mixed mature trees across the site.

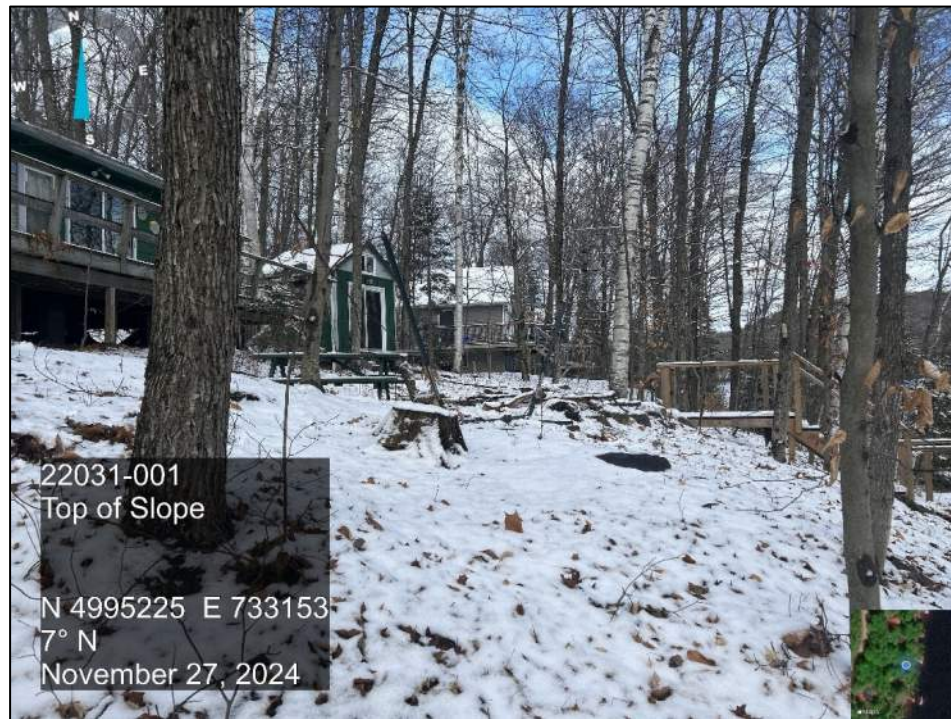
**Photo 5** View of top of the slope, looking north, showing a residential structure, staircase, and mixed mature trees.

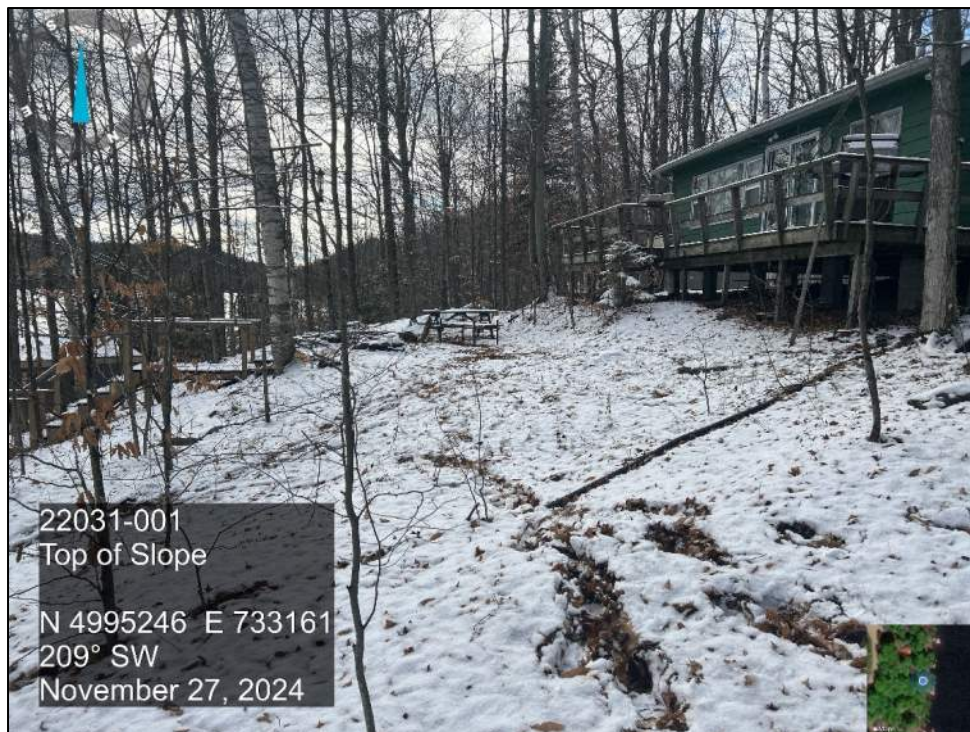
**Photo 6** View of top of the slope, looking south, showing a residential structure, staircase, and mixed mature trees.

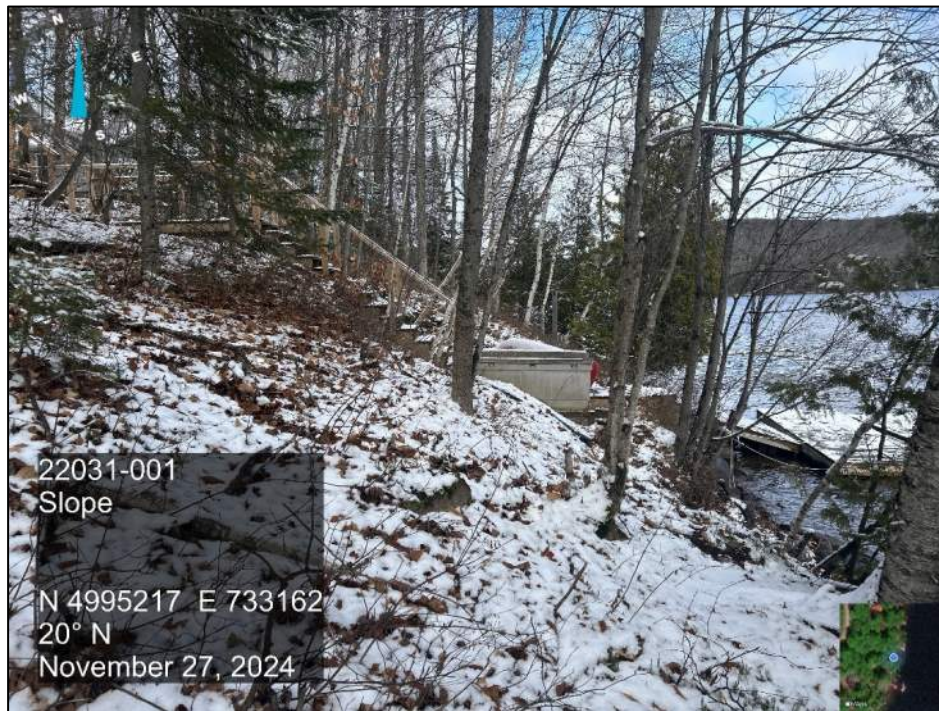
**Photo 7** View of the slope face, looking north, showing mixed mature trees, staircase, dock, and Diamond Lake.

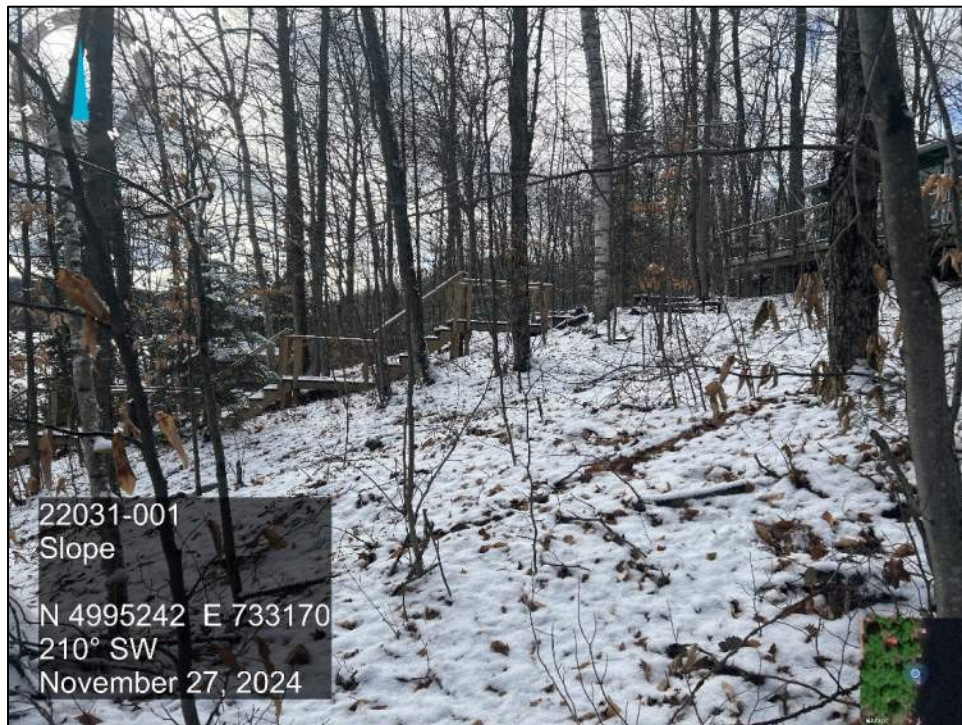
**Photo 8** View of the slope face, looking south, showing mixed mature trees, staircase, and a residential structure.

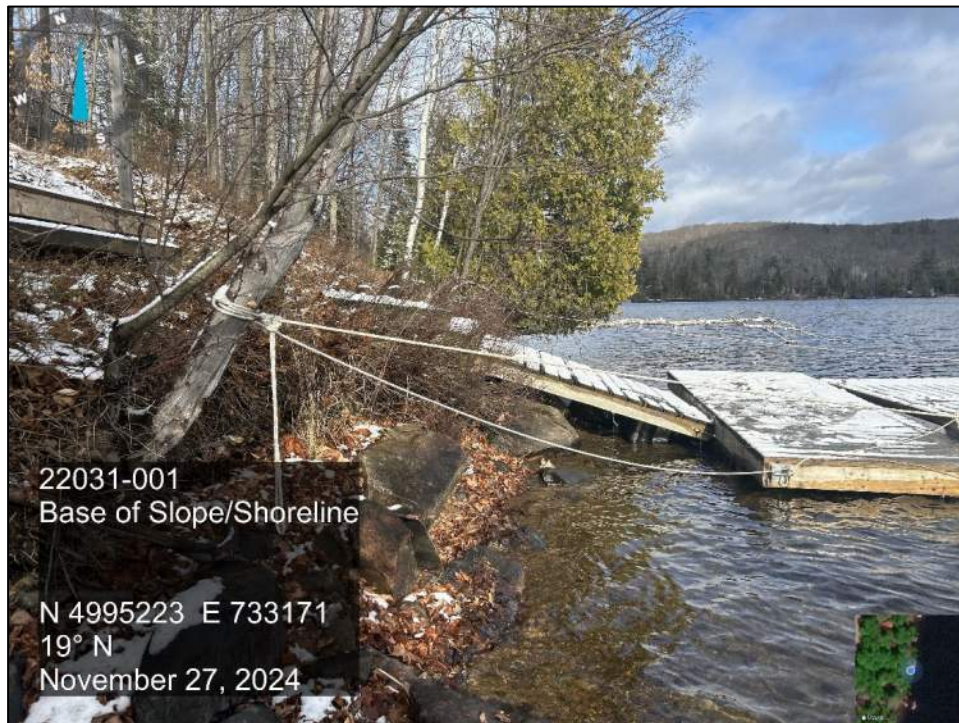
**Photo 9** View of the base of the slope, looking north, showing the occasional bent tree, large boulders, mixed mature trees, a dock, staircase, and Diamond Lake.

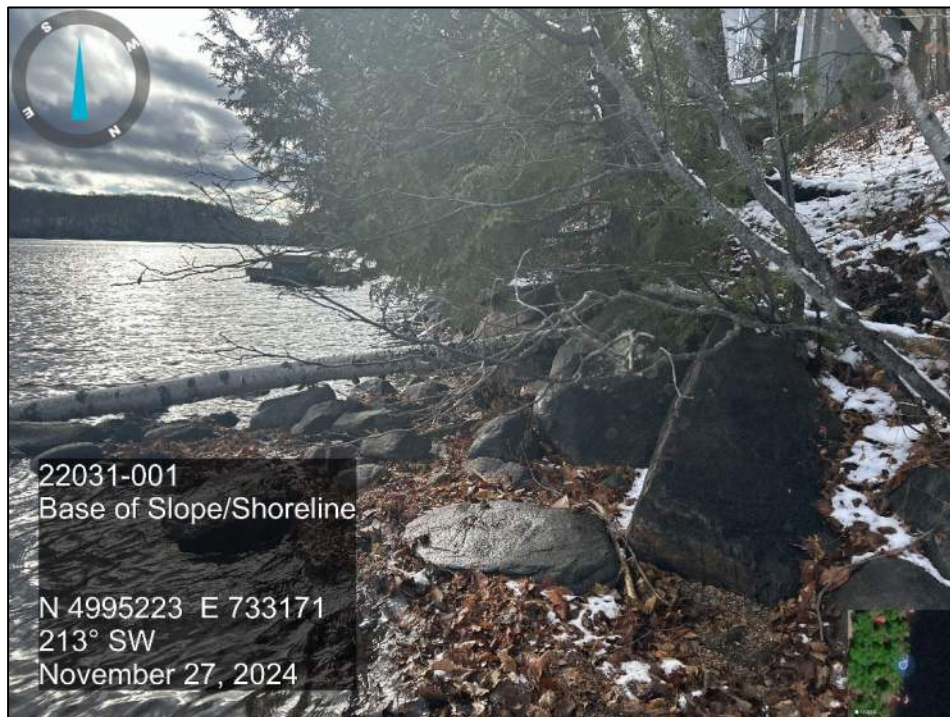
**Photo 10** View of the base of the slope, looking south, showing the occasional bent tree, large boulders, coniferous trees, and Diamond Lake.

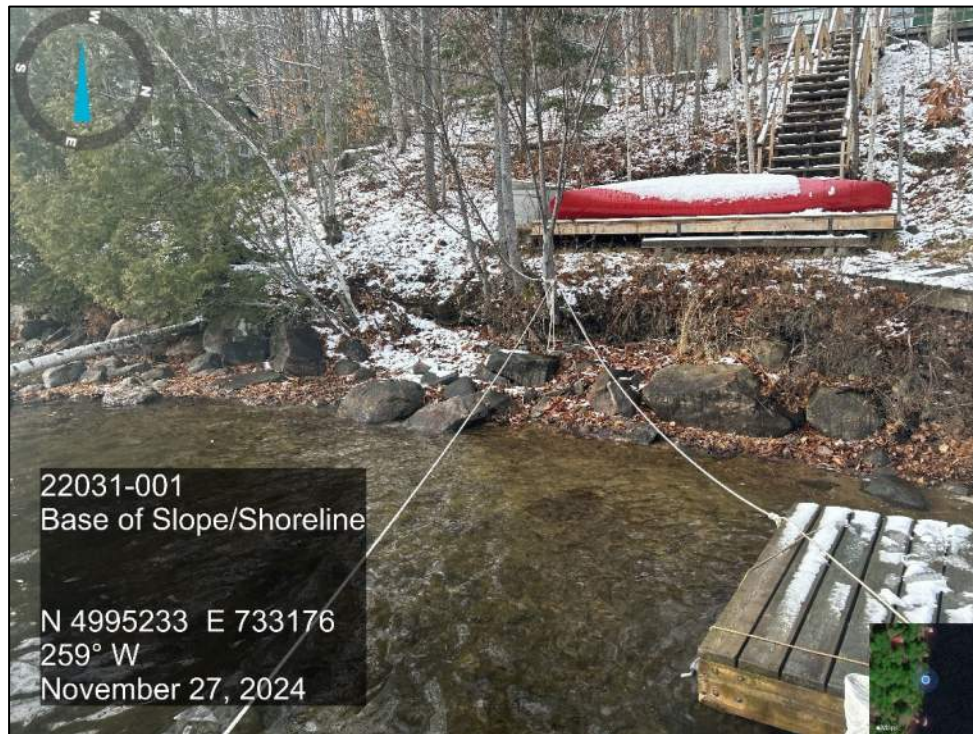
***Photo 11 View from the dock, looking west towards the base of the slope/shoreline, showing mixed mature trees, a dock, and a staircase. Large boulders exposed along the base of the slope.***
