January 6, 2025

Re: Slope Stability Assessment – Proposed Residential Redevelopment, 141 Marina Road, Hastings Highlands, ON Cambium Reference: 22175-001

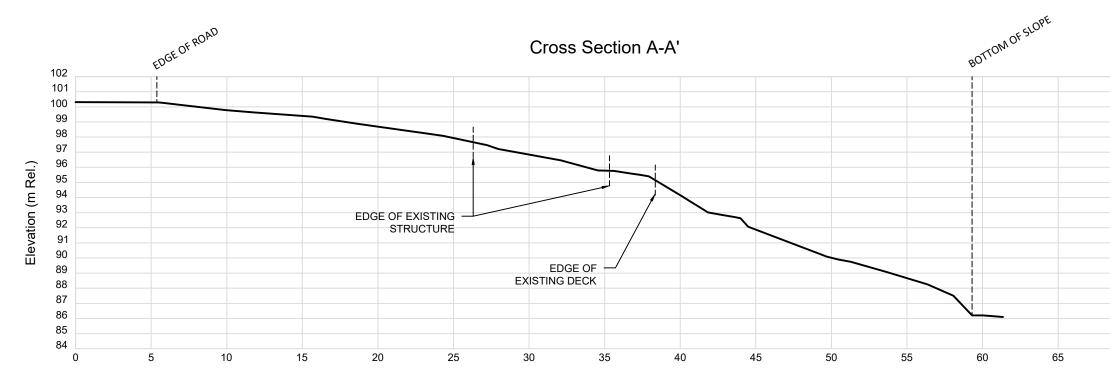
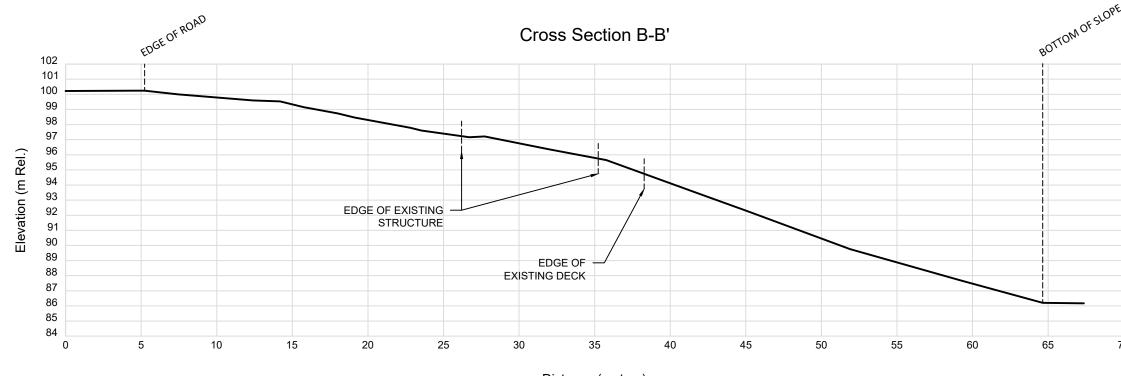
The north side of the site exhibits sloping topography associated with Baptiste Lake. The toe of the slope is located approximately 13 m below site grade, with steepest inclination approaching about 2.2H:1V. A site plan is appended as Figure 2 of this report.

Cambium also conducted a limited slope survey by using a Real-Time Kinematic (RTK) survey equipment, to illustrate cross sections (as shown on Figure 3) of the existing slope for discussion.

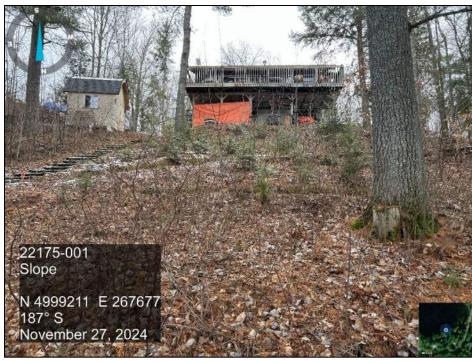
Photo 3 Site overview, looking south, showing a residential building and small building near the top of the slope and mixed mature trees. Cross section A-A taken along the west side of the residential structure, Cross section B-B taken along the east side of the residential structure.

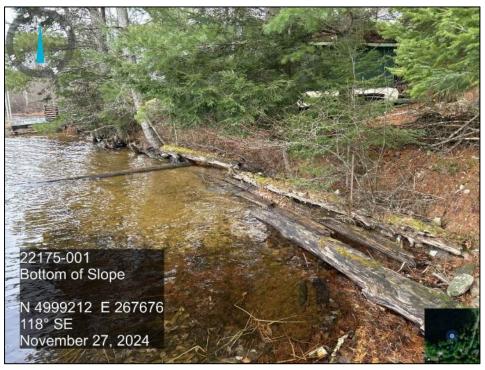
The toe erosion allowance is defined by the recession of the toe of the valley slope (MNR, 2002). Based on site observation, the type of material of the toe can be described as " Coarse Granular Tills". No active erosion was observed at slope across the entire site. As per Table 3 of the MNR Technical Guidelines, the toe erosion allowance is considered to be 4 m, which is naturally achieved provided adequate distance between the shoreline and the physical toe of the slope.

Photo 10 View of the base of the slope, looking east, showing the shoreline of Baptiste Lake and mixed mature trees.

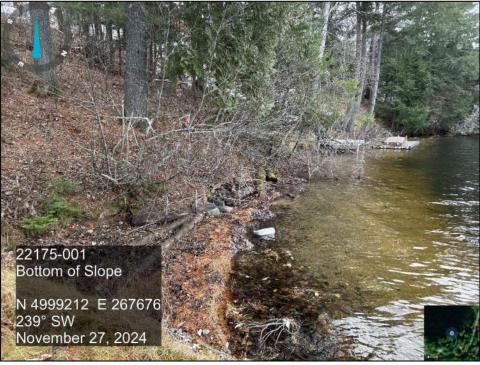
Photo 11 View of the base of the slope, looking west, showing the shoreline of Baptiste Lake and mixed mature trees.

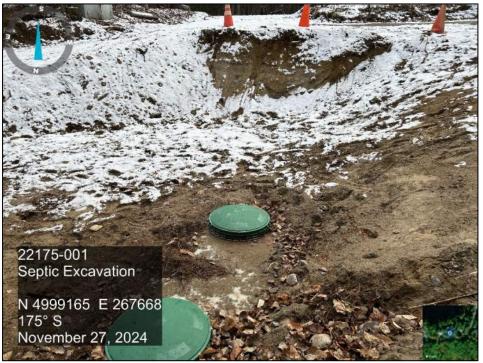
A newly constructed septic area was utilized as test pit for inspection purpose. The soils exposed on the sides of the excavation were classified by visual and tactile examination while the septic area has not been backfilled. Within the exposed excavation, the material appears to be sand or silty sand down to the termination depth (as shown in Appendix A - photo 12). No soil sample was retrieved during investigation.

Photo 12 View of the newly constructed septic area, immediately south of the residential structure.

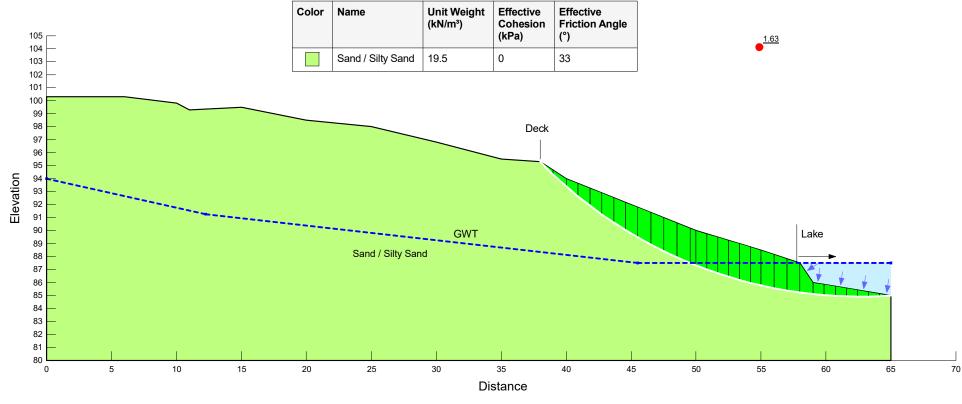
Section A-A, Existing Conditions

A preliminary engineering analysis of slope stability was carried out for one interpreted cross-section (Section A-A) by utilizing Slope/W (Version 23.1.0), an industry standard two-dimensional limit equilibrium slope modelling program.

A piezometric line defining the pore-water pressure condition was illustrated on the model. The stability assessment was based on a limit equilibrium analysis for long term slope stability using Morgenstern–Price method.

Cognizant of the observed satisfactory performance of the existing slope and the vegetation cover (grass, weeds, shrubs, and trees), the analysis has not considered the cases for shallow slip plane. The analysis results indicate a factor of safety (FOS) of 1.63, which is greater than 1.5 with respect to the industry standards as well as *MNR technical guidelines*.
