**Re: Slope Stability Assessment – Proposed Residential Redevelopment,  
115 Rangers Road, Highland Grove, ON  
Cambium Reference: 22370-001**

**SLOPE STABILITY  
ASSESSMENT**  
JUSTIN AND NICOLE FLOWERDAY  
115 Rangers Road  
Highland Grove

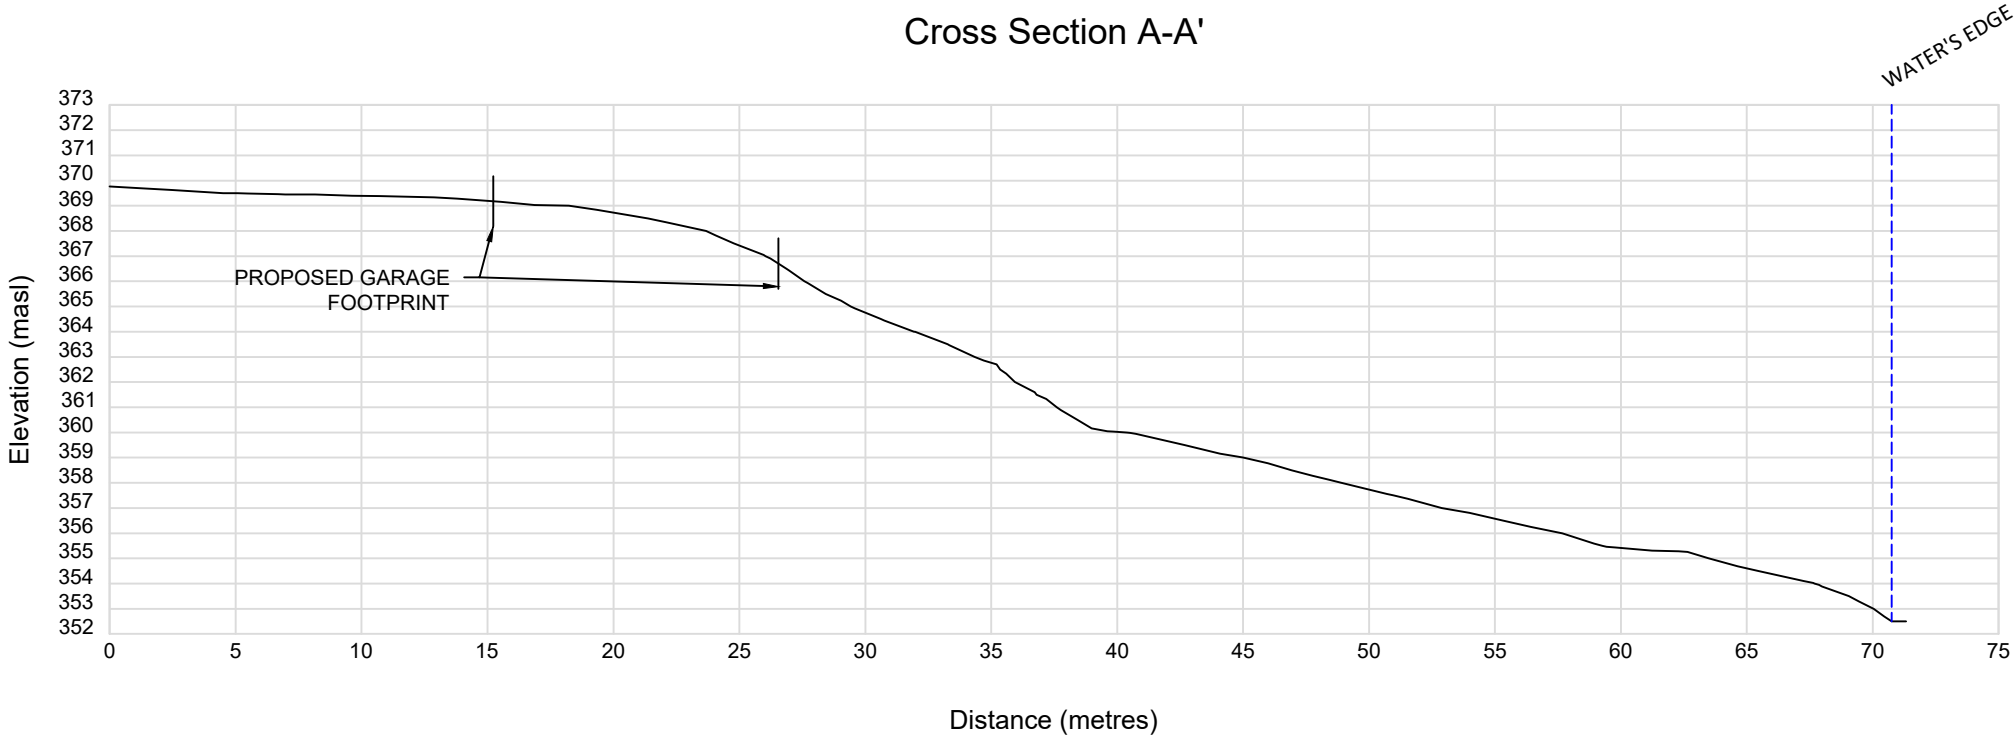
Cross Section A-A'

The toe erosion allowance is defined by the recession of the toe of the valley slope (MNR, 2002). Based on site observation, the type of material of the toe can be described as "Hard Rock (granite)". No active erosion was observed at slope across the entire site. As per Table 3 of the MNR Technical Guidelines, the toe erosion allowance is considered to be 0 m.

Based on the inclination of the existing slope (flatter than 3H:1V), the existing slope is considered to be long term stable, i.e. the existing top of slope line will be the same as long term stable top of slope line.

Considering there is no active erosion along the toe of the slope at Baptiste Lake, and it appears access can be provided through the east edge of the property line instead of the existing slope crest, we do not foresee the requirement for Erosion Access Allowance. The existing top of slope line will be the defined erosion hazard limit line.

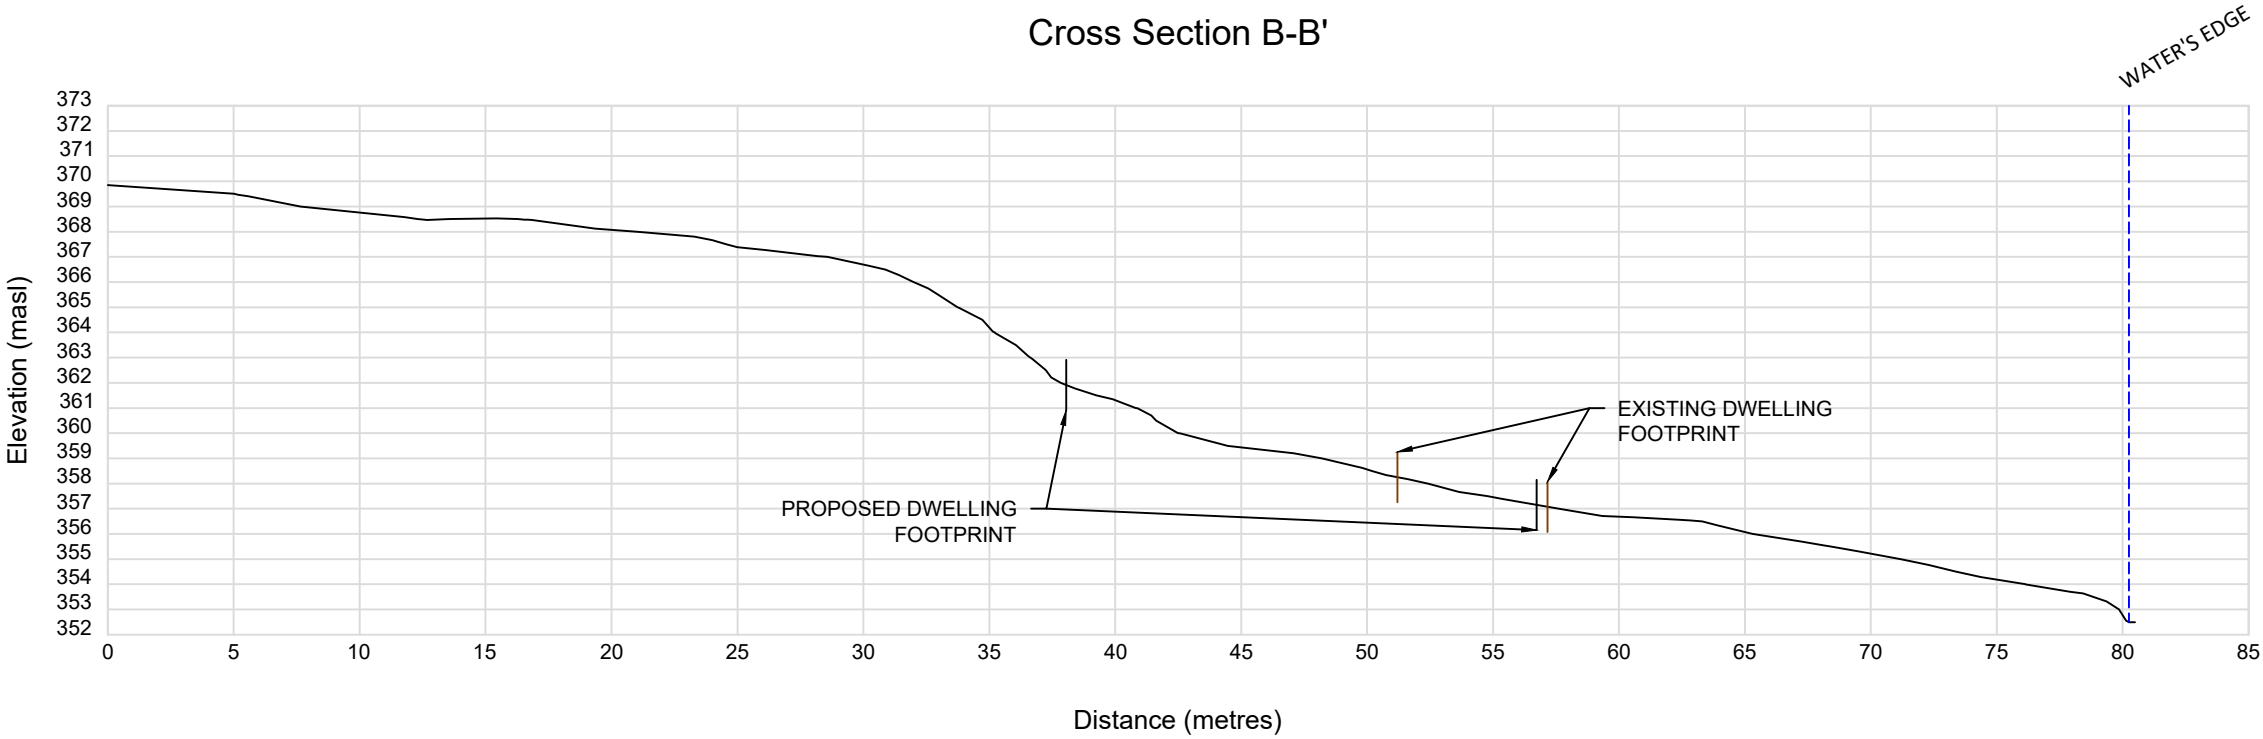
Cross Section B-B'

For the upper portion of the slope, based on the surficial geology and subsurface condition as investigated, we do not foresee the requirement for a standard 3H:1V stable slope allowance. In Ontario, for hard rock condition (granite), it is quite common to see design slope inclinations steeper than 1H:1V. Therefore, the existing slope is considered to be long term stable, i.e. the existing top of slope line will be the same as long term stable top of slope line.

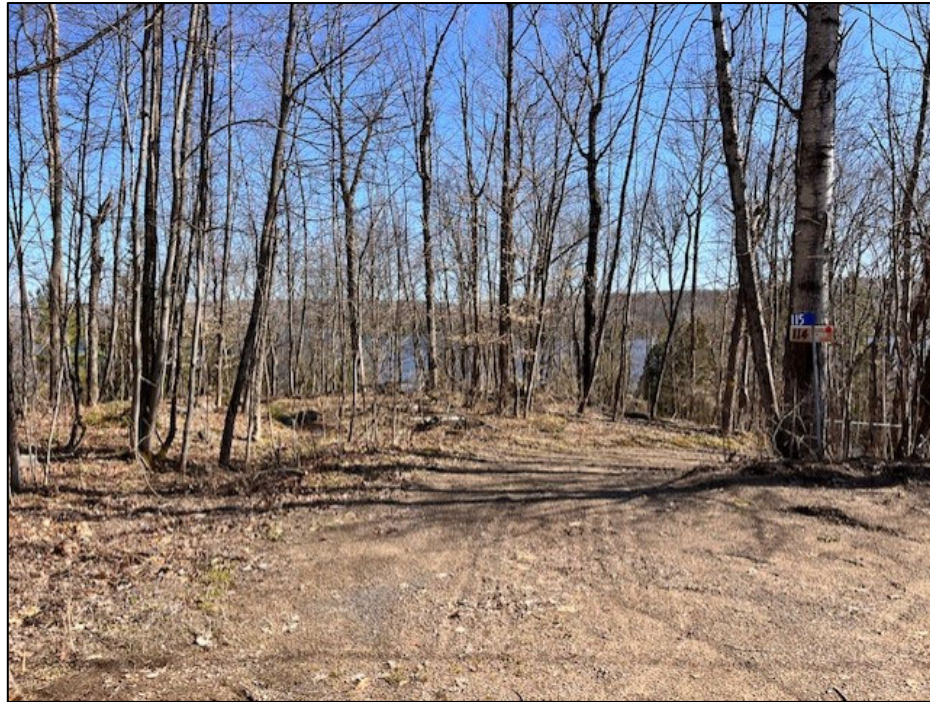
***Photo 1 Site overview, looking north, from Rangers Road, showing mixed mature trees across the top of the upper slope area.***

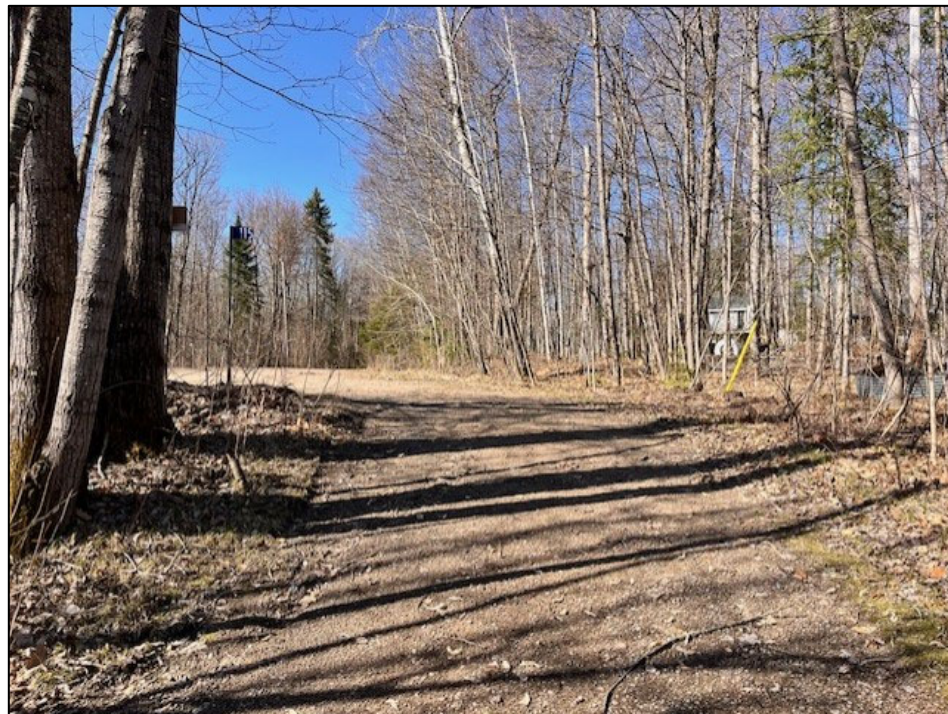
***Photo 2 View of the table land for the slope at the top of the upper slope area, looking west, showing mixed mature trees, and Rangers Road.***

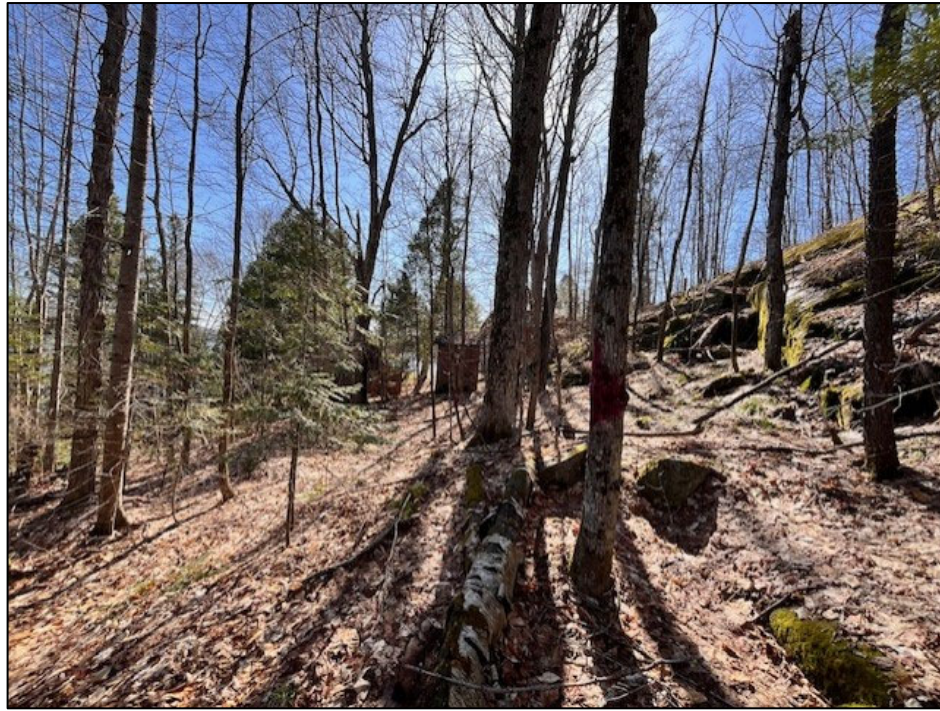
**Photo 3** View of slope face for the upper steep section, looking east, showing an outhouse structure, with mixed mature trees and exposed bedrock.

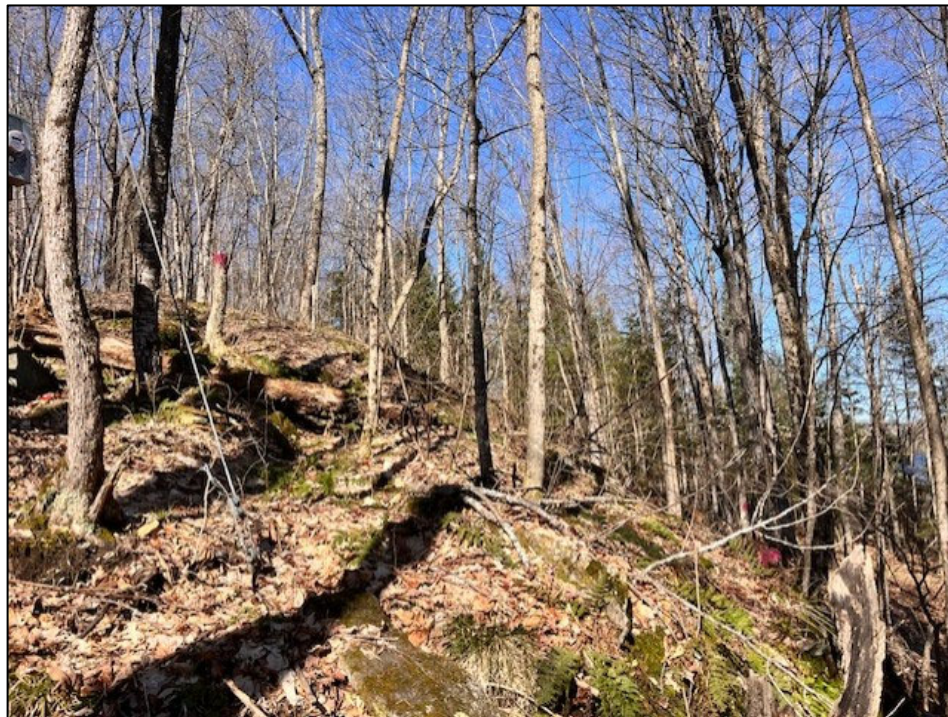
**Photo 4** View of slope face for the upper steep section, looking west, showing mixed mature trees and exposed bedrock.

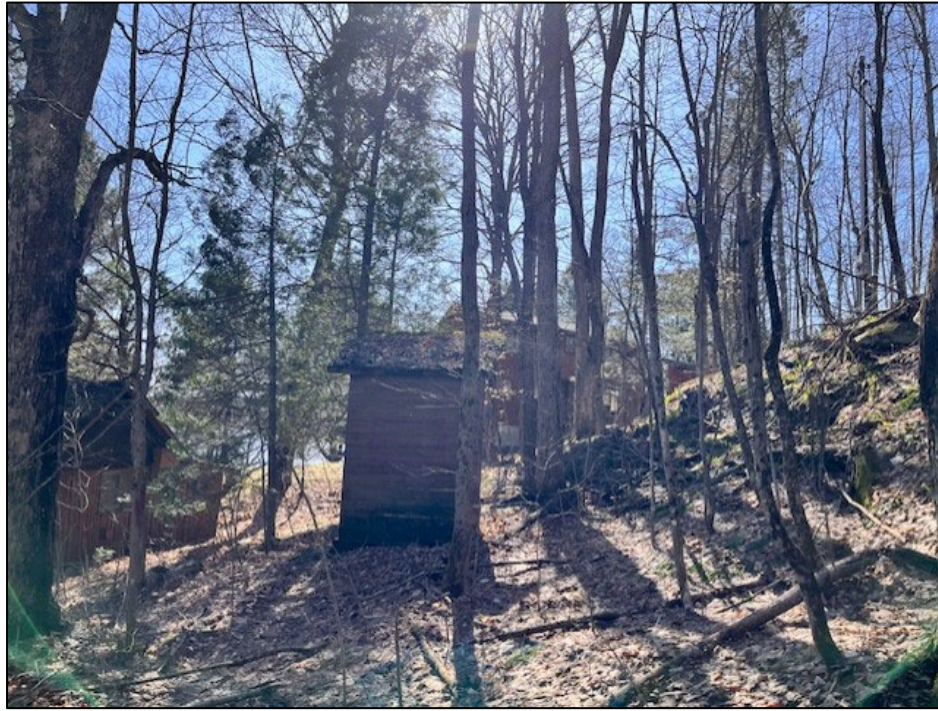
***Photo 5 View of slope face near the bottom of the upper steep section and the top of lower less steep section, looking east, showing the existing residential structure, an outhouse structure, neighbouring residential structure, mixed mature trees, and exposed bedrock.***

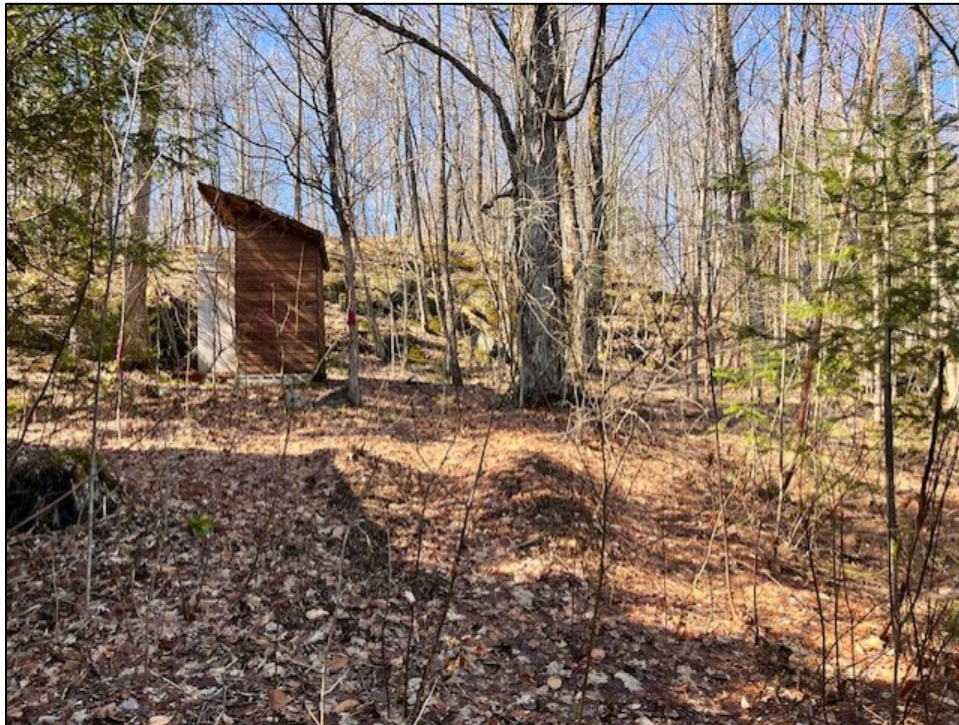
***Photo 6 Site overview, looking up the lower and upper slope sections, looking south, showing an outhouse structure. Mixed mature trees and bedrock are seen.***

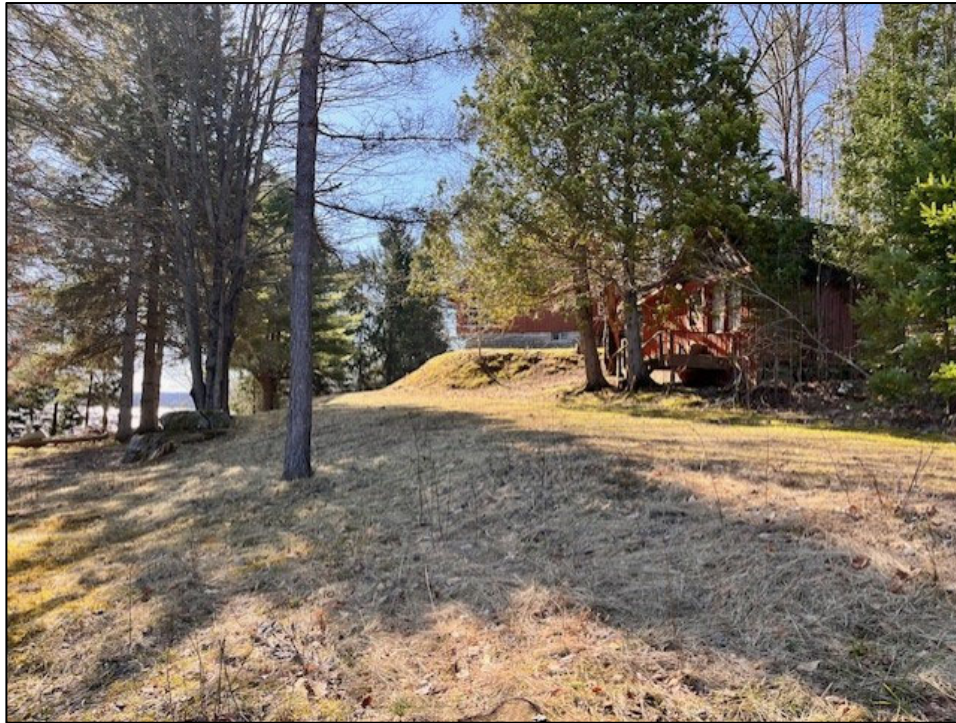
***Photo 7 View of slope face near the top of the lower less steep section, looking east, showing the existing residential structure and neighbouring residential structure. Mixed mature trees are observed around a grassy cleared area.***

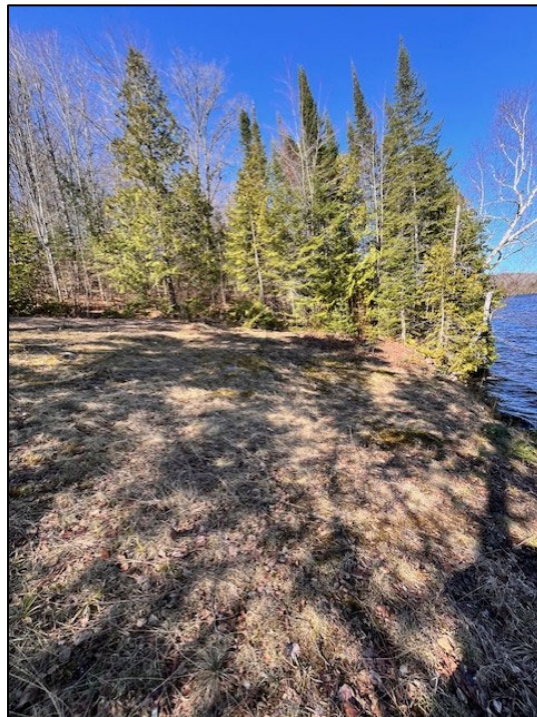
***Photo 8 View of slope face near the base of the lower less steep section, looking west, showing mixed mature trees around a grassy cleared area. Baptiste Lake is observed north of the property.***

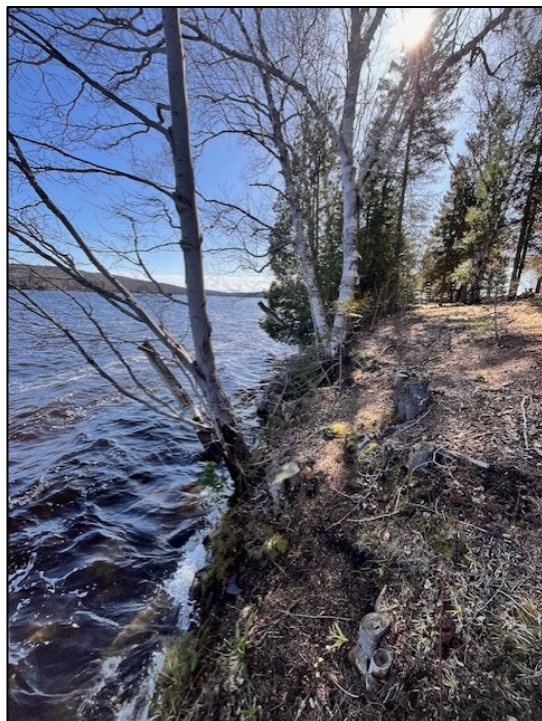
mature trees (refer to appended photographs). There was no evidence of significant tree root or trunk creep. Boulders were evident along the shoreline.

***Photo 9 View of the base of the slope, looking east, showing Baptiste Lake and mixed mature trees and boulders along the shoreline.***

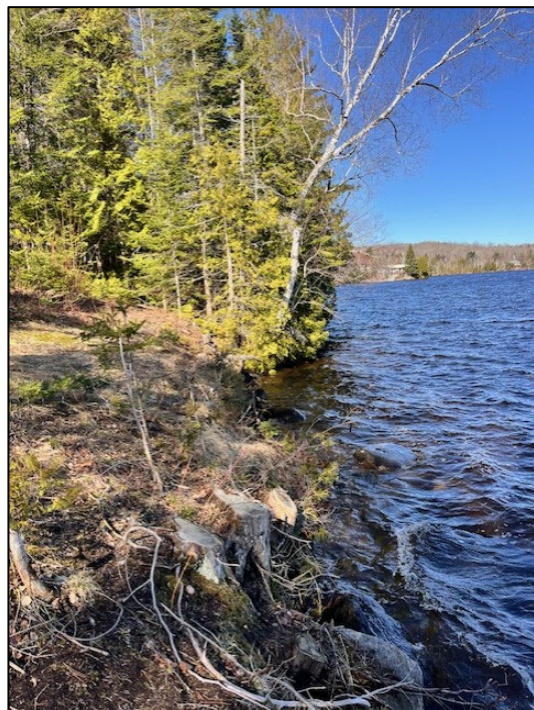
deciduous and coniferous trees and there is no evidence of active erosion near the lake. Some large boulders were observed along the existing shoreline. Bedrock outcrop was observed along the upper steeper portion.

***Photo 10 View of the base of the slope, looking west, showing Baptiste Lake and mixed mature trees and boulders along the shoreline.***
