Scoped Environmental Impact Study (EIS)

Reed/Ruppert Property
Part of Lot 17, Concession 7,
Geographic Township of Bangor,
Township of Hastings Highlands,
Hastings County

December 19, 2024

Jp2g Project # 24-7085A

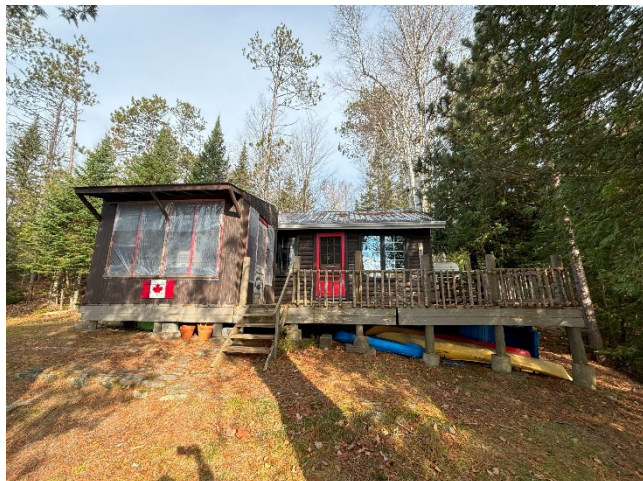
An existing cottage, trailer, deck, septic system, driveway, access road and storage shed are located within the main developed area of the subject lands (Photos 1 & 2) in the central portion of the property as shown on **Map 2**.

*Photo 1 – Existing Cottage & Deck.
View Looking North.*

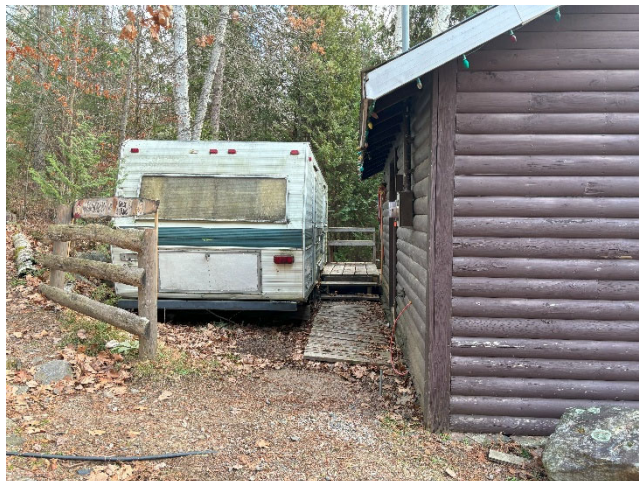
The existing cottage, trailer, shed and septic system on the subject lands are located within the area of the 30-metre water setback from Purdy Lake. The existing trailer and a portion of the existing deck between the cottage and the trailer will be removed and a 34.8 m² addition to the existing cottage will be constructed at the rear of the existing cottage, approximately 22 metres from the highwater mark of the Lake. The proposed addition will not be located any closer to the highwater mark of the Lake than the existing cottage which is located approximately 12 metres from the highwater mark of the Lake.

*Photo 2 – Existing Trailer at Back of Cottage.
View Looking East.*

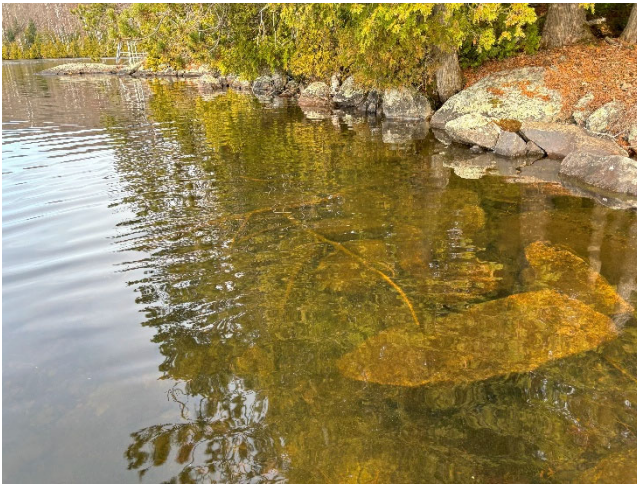
During the November 19, 2024 site visit to the subject lands, the near-shore fish habitat along the shoreline of the subject lands was mapped as shown on **Map 2** (Photo 5). The shoreline of the subject lands is rocky and moderately slopes towards the lake. Very little vegetation was noted in the lake itself. Large rocks, stones, pebbles, as well as fallen needles, branches and logs were noted in the bottom of the lake. No sensitive fish habitat features, such as coarse beds for potential fish spawning, were noted along the shoreline of the subject lands.

*Photo 5 – Site Conditions of Near Shore Fish Habitat.
View Looking Northwest.*

- f. Erosion and sediment control measures are a critical component of the construction work. Effective sediment and erosion control measures are to be maintained until complete re-vegetation of disturbed areas is achieved. Silt fencing is to be installed along the downgradient edges of the work areas. It is important that fencing is properly dug-in to treat any surface water flow and is maintained as required, including removal of accumulated sediment.

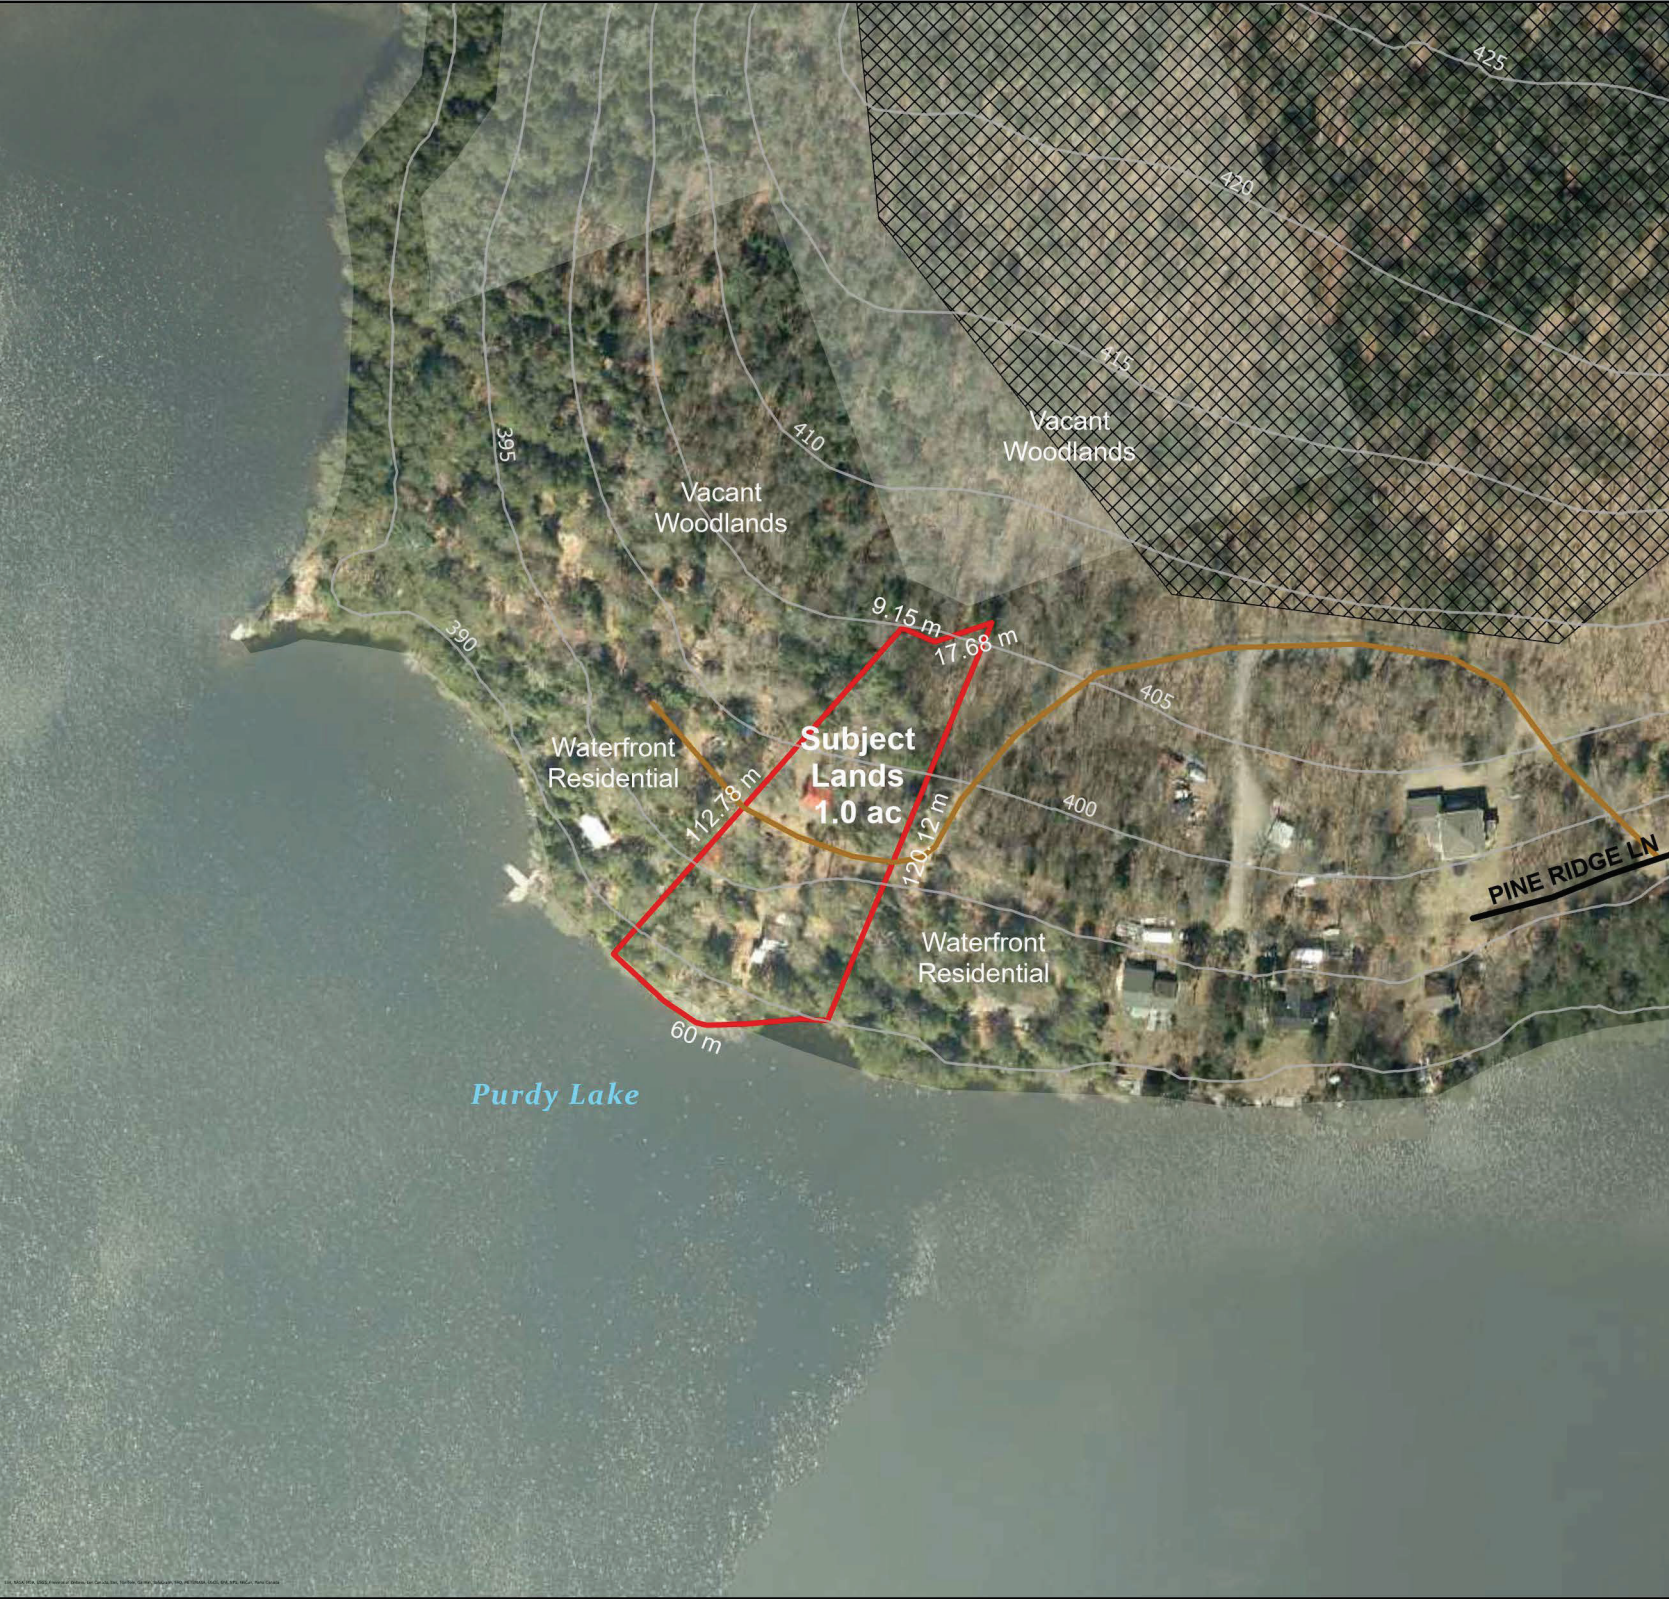
MAP 1:
SITE & SURROUNDING LAND USE

The subject lands are located near the end of Pine Ridge Lane on Purdy Lake, within Part of Lot 17, Concession 7, in the Geographic Township of Bangor, now in the Township of Hastings Highlands. The subject lands as shown on **Map 1** are approximately 1.0 acre in land area with 63.7 metres of water frontage on Purdy Lake. The Pine Ridge Lane right-of-way travels through the subject lands, as shown on **Map 2**.

The subject lands are primarily vacant woodlands and contain an existing cottage, trailer, bunkie, sheds and a septic system. The land use in the vicinity of the subject lands as shown on **Map 1** includes vacant woodlands, crown land and existing waterfront residential development along Pine Ridge Lane on Purdy Lake.

Schedule B of the Hastings County Official Plan (County of Hastings Planning & Development Department, 2018) was reviewed for Natural Heritage Features and Areas on and adjacent to the subject lands. No natural heritage features or areas are identified on the subject lands, however a Deer Wintering Area (Stratum 2) is located on the adjacent lands to the northeast as shown on **Map 1**.

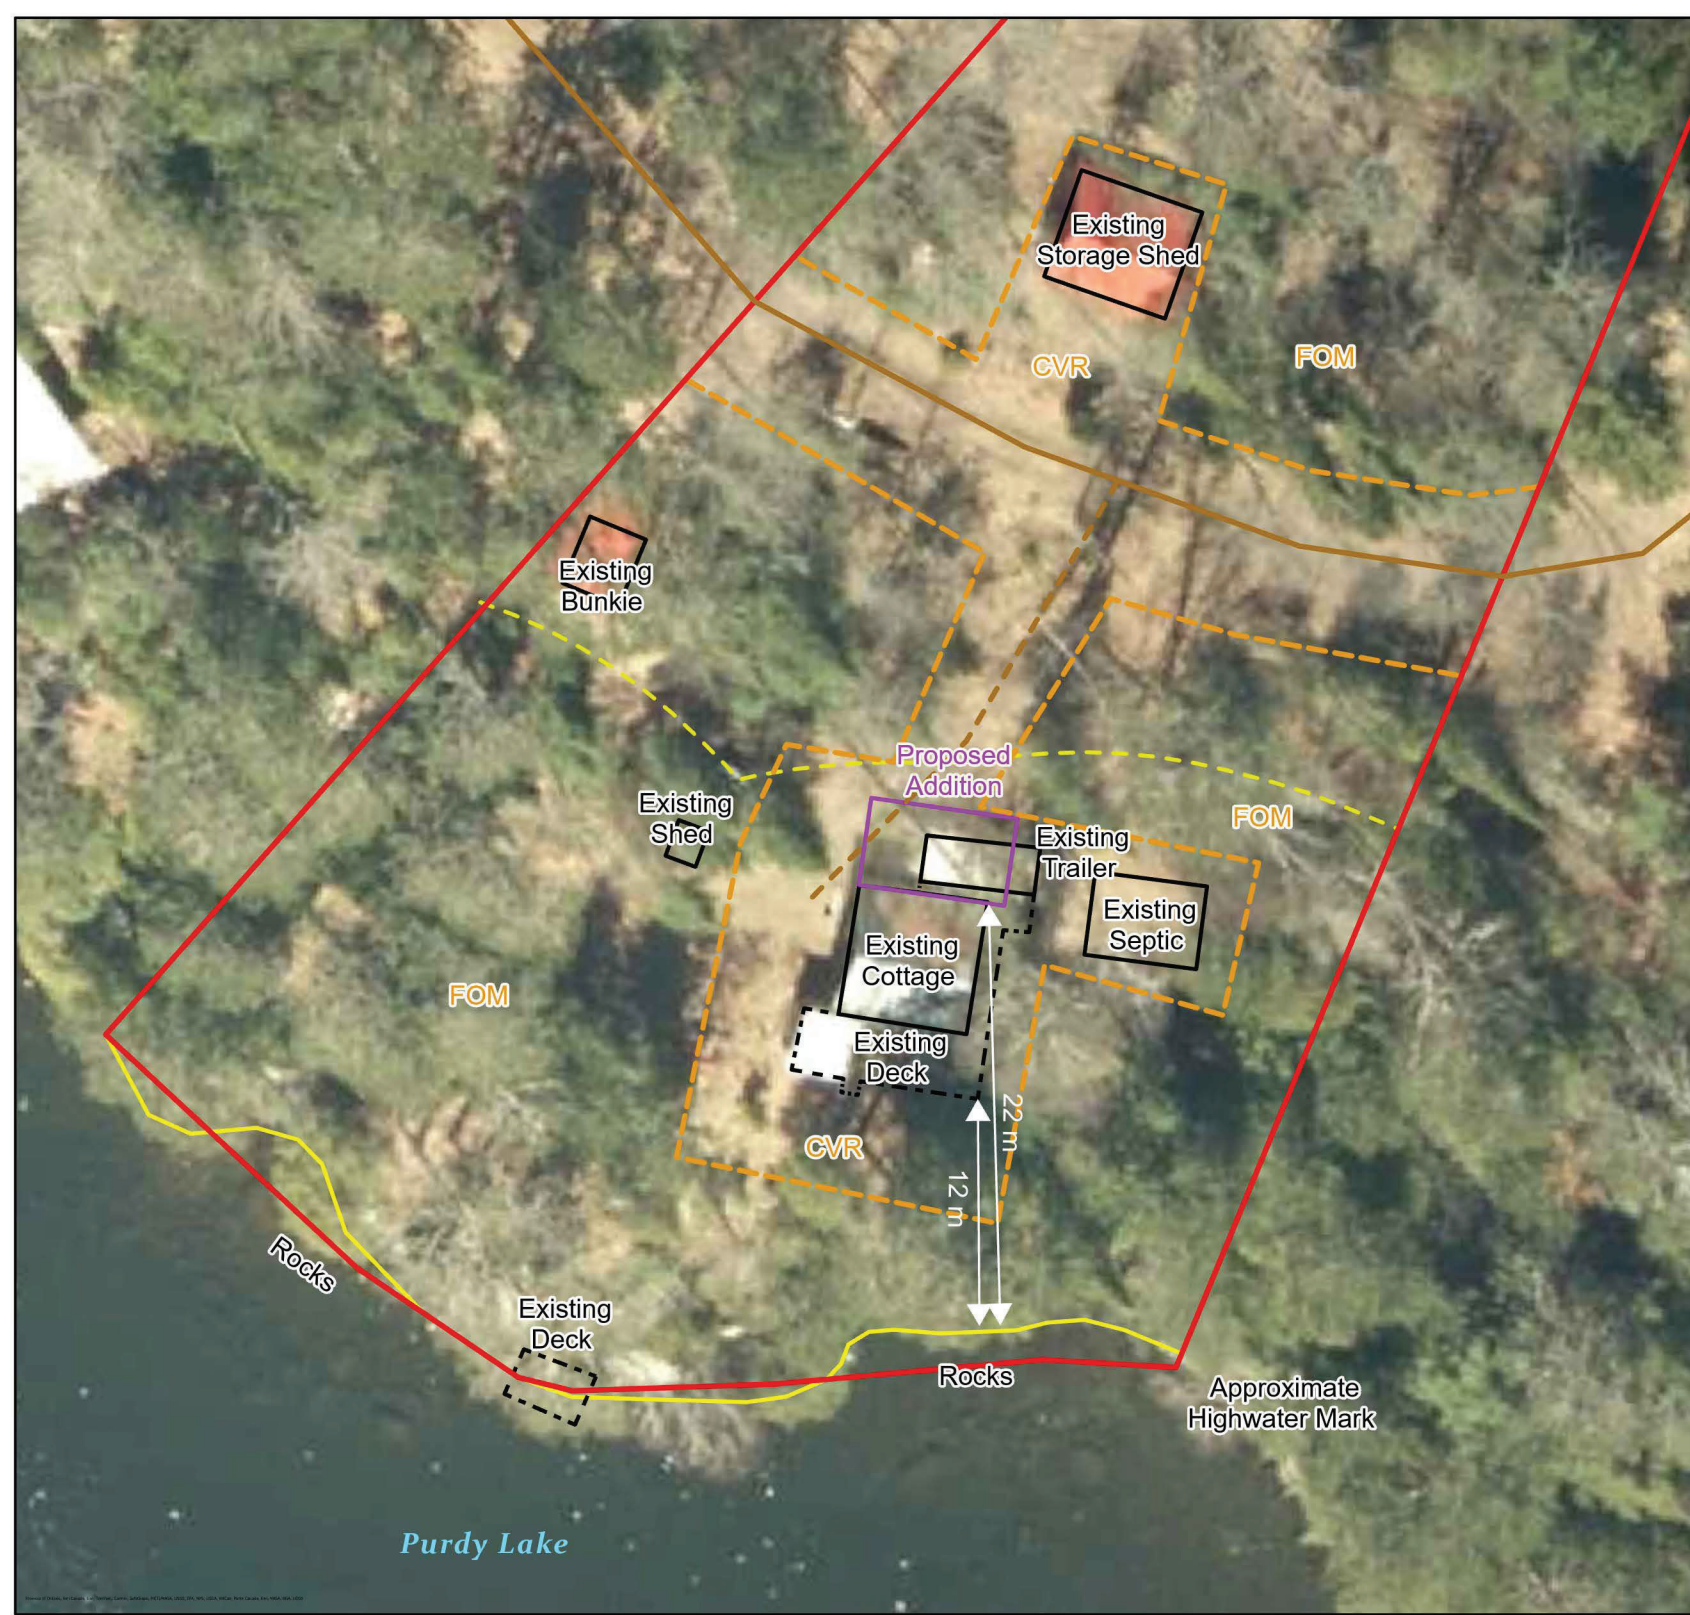
MAP 2:
SUBJECT LANDS

The approximate size and the location of the existing buildings and structures are shown on **Map 2**.

The approximate dimensions and location of the proposed cottage addition has also been shown on **Map 2**, however, the exact dimensions and location will be determined once it has been fully designed.

In this case, the existing cottage, decks and trailer are located within the area of the water setback, approximately 12 metres from the highwater mark of the Lake. The existing trailer and a portion of the existing deck (located at the back of the existing cottage) are proposed to be removed and a new addition to the cottage will be constructed in its place, approximately 22 metres from the highwater mark of the lake. The location of the highwater mark of the lake as shown on **Map 2** was determined based on a site visit to the property as well as air photo interpretation.

A conceptual layout for the proposed addition within the area of the water setback is shown on **Map 2**. The size and location of the proposed addition could change as it has not been designed yet. Provided, the proposed addition is located at least 22 metres from highwater mark of the Lake, this report does not need to be amended to show the correct location and size of these features once they have been designed.

- a. The new addition is to be constructed at least 22 metres from the highwater mark of the lake.
 - b. A 12 metre wide buffer area in front of the existing cottage and deck is to be maintained along the shoreline of Purdy Lake. This buffer area should be maintained substantially in a natural vegetated state, with the exception of the existing shoreline activity area along Purdy Lake as well as the limbing of trees to provide for a view of the Lake and the removal of dead or diseased trees.
