Scoped Environmental Impact Study (sEIS) Proposed Single Residential Redevelopment 38B Baileys Road East (Lot 8), Papineau Lake Part Lot 2, Concession 6 (Wicklow) Municipality of Hastings Highlands, County of Hastings

ORE File No. 25-3543

May 2025

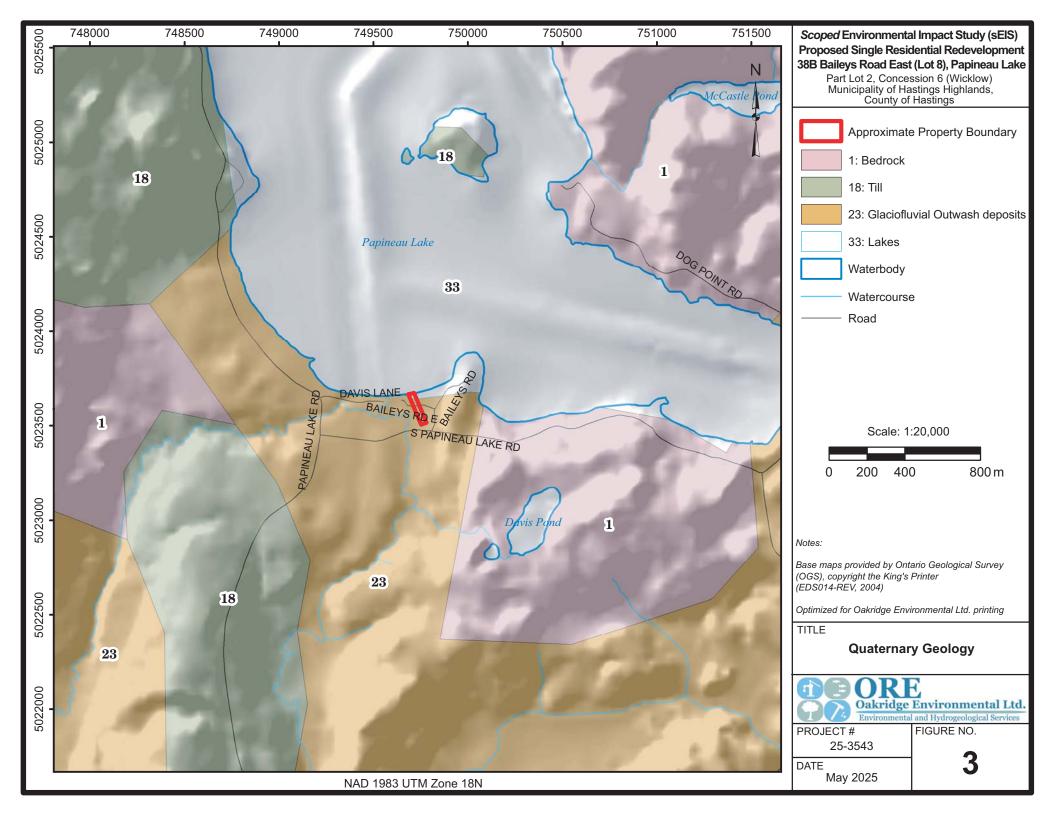
As illustrated by Figure 3, the subject site occurs within an area of glaciofluvial outwash deposits. These highly permeable sand and gravel deposits occupy the valley lands containing the subject site and are likely partly responsible for the low topographic relief. An area licensed for aggregate extraction is mapped about 1.2 km southwest of the site (where the topography rises), likely exploiting those deposits (Figure 2).

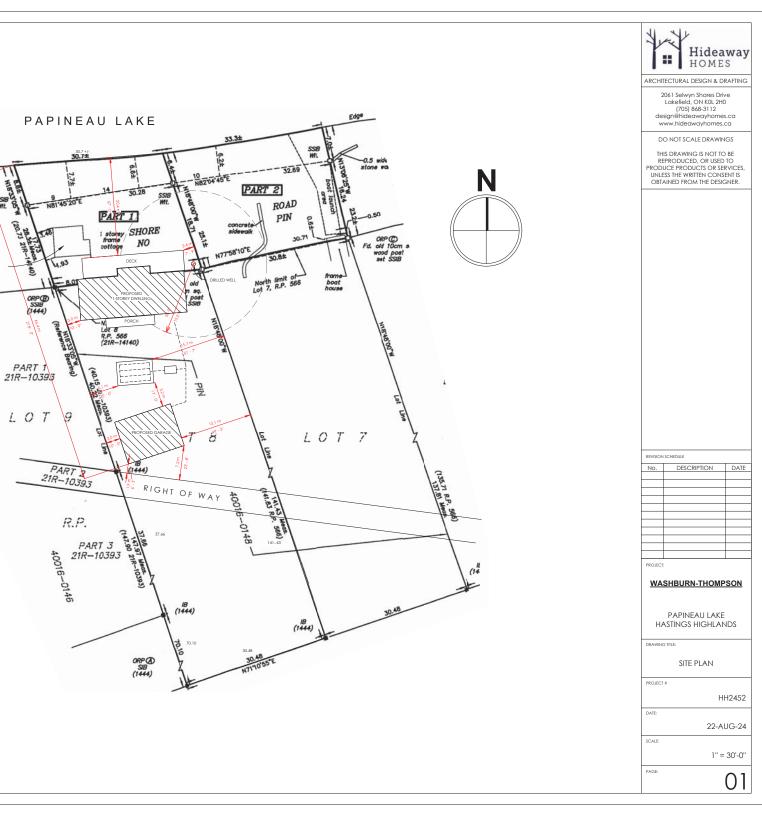
Proponent's Conceptual Site Plan

EXISTING COTTAGE TO BE DEMOLISHED

The reader is referred to the proponent's conceptual site plan (Appendix A).
