January 6, 2025

Re: Slope Stability Assessment – Proposed Residential Redevelopment, 141 Marina Road, Hastings Highlands, ON Cambium Reference: 22175-001

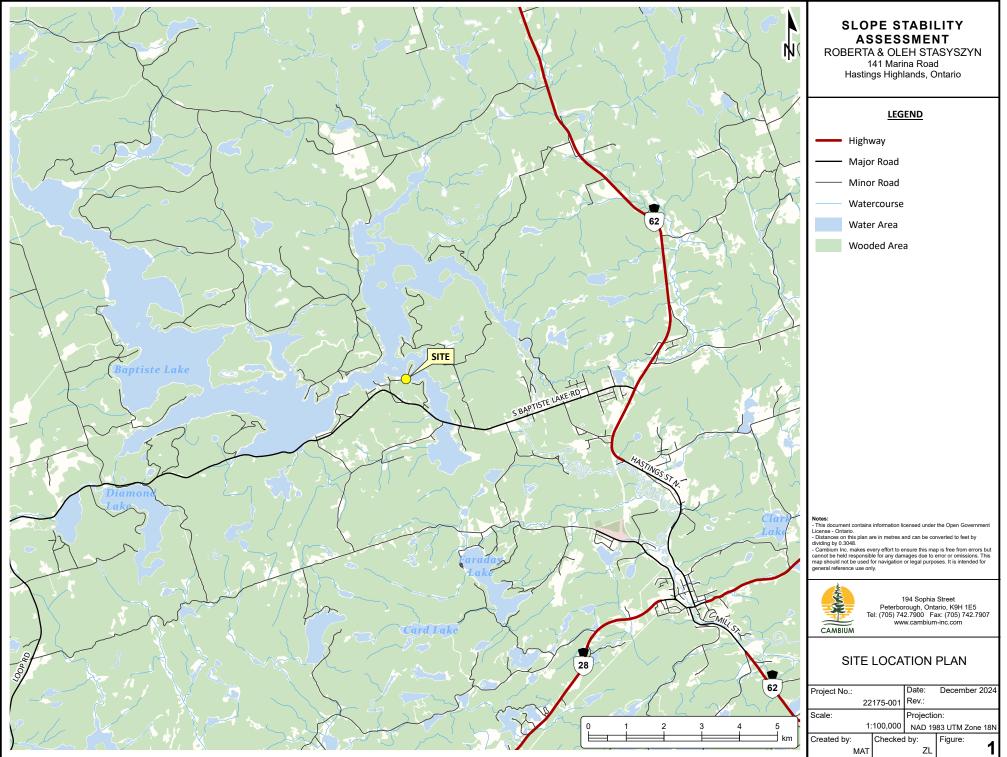
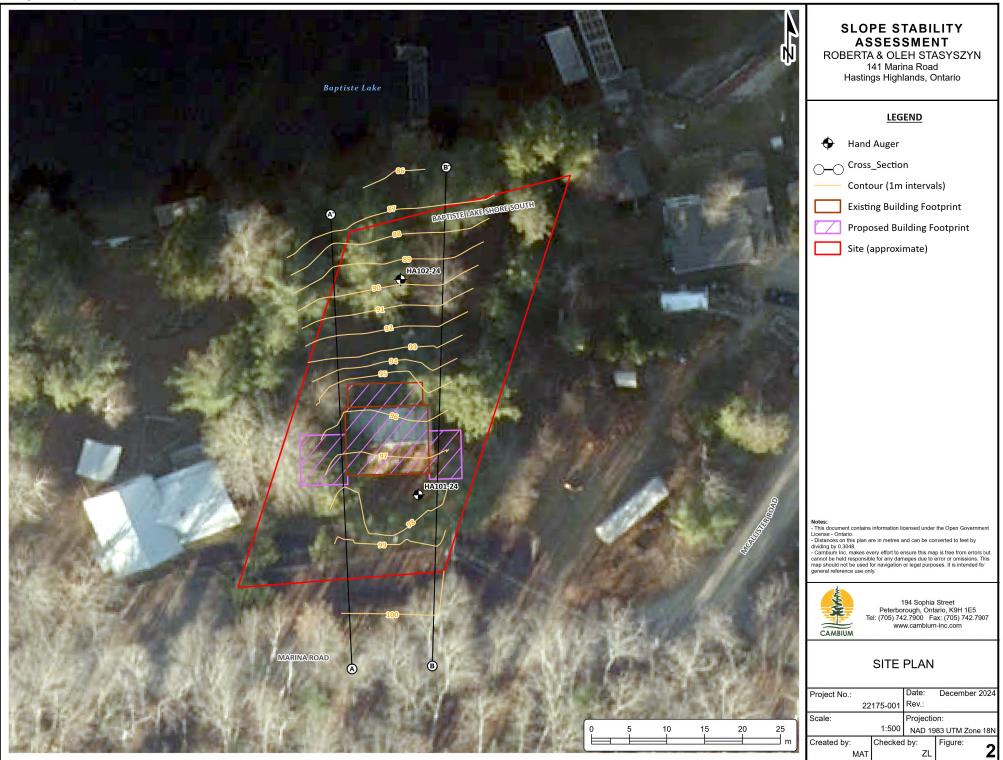
The north side of the site exhibits sloping topography associated with Baptiste Lake. The toe of the slope is located approximately 13 m below site grade, with steepest inclination approaching about 2.2H:1V. A site plan is appended as Figure 2 of this report.

Cambium also conducted a limited slope survey by using a Real-Time Kinematic (RTK) survey equipment, to illustrate cross sections (as shown on Figure 3) of the existing slope for discussion.

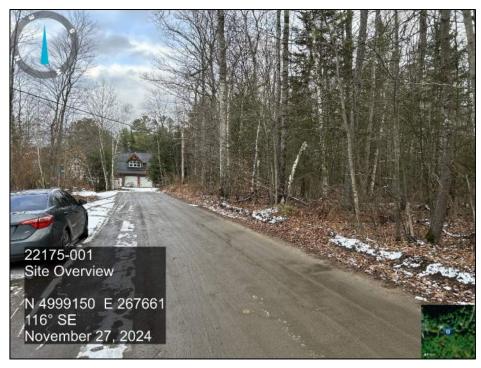
Photo 1 Site overview, looking east along Marina Road, showing the road, table land, and mixed mature trees.

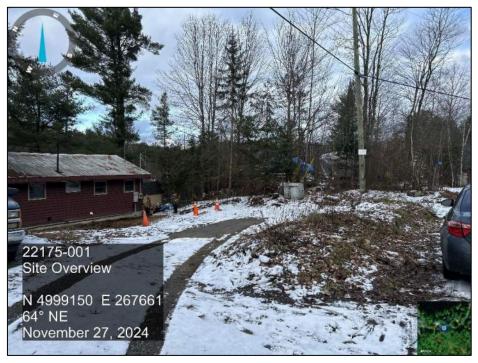
Photo 2 Site overview, looking northeast, showing a residential building, driveway area, septic area, proposed mudroom area, and mixed mature trees.

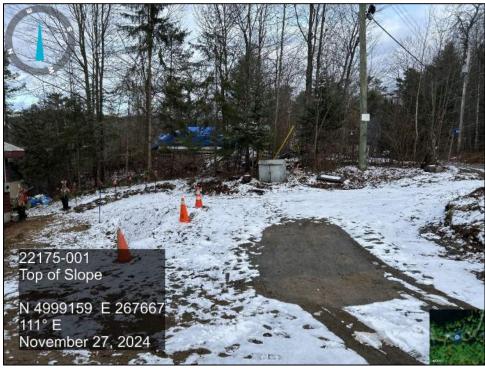
Photo 4 View of top of the slope, looking east, showing driveway area, Marina Road, and mixed mature trees.

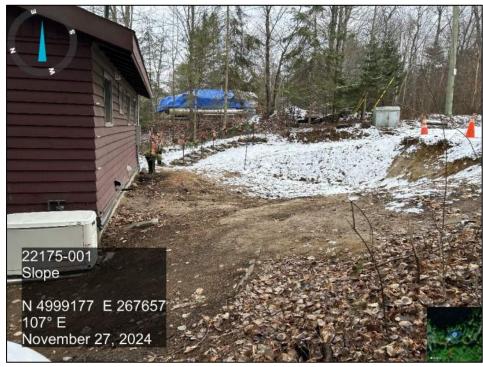
Photo 5 View of the slope, looking east, showing a residential structure, septic area, proposed garage area, and mixed mature trees.

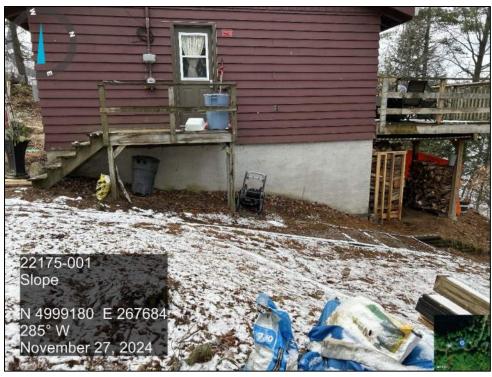
Photo 6 View of the slope, looking west, showing a residential structure, proposed deck enclosure area, proposed mudroom area, and mixed mature trees.

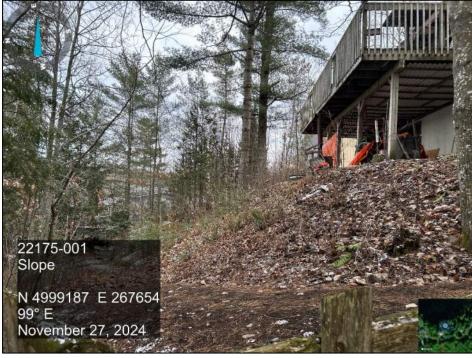
Photo 7 View of the slope, looking east, showing a residential structure, proposed deck enclosure area, and mixed mature trees.

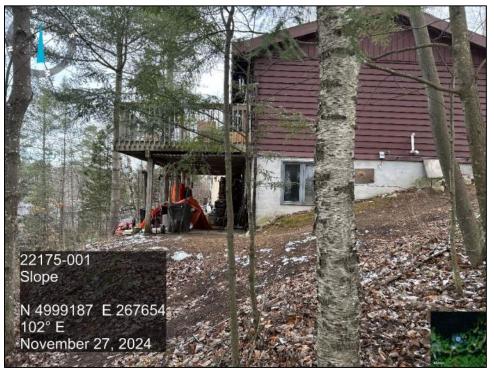
Photo 8 View of the slope, looking east, showing a residential structure, proposed garage area, proposed deck enclosure area, and mixed mature trees.

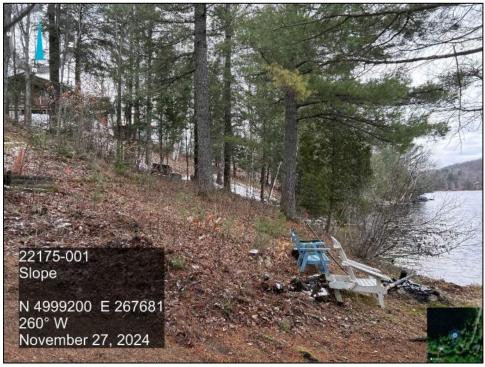
The toe erosion allowance is defined by the recession of the toe of the valley slope (MNR, 2002). Based on site observation, the type of material of the toe can be described as " Coarse Granular Tills". No active erosion was observed at slope across the entire site. As per Table 3 of the MNR Technical Guidelines, the toe erosion allowance is considered to be 4 m, which is naturally achieved provided adequate distance between the shoreline and the physical toe of the slope.

Photo 9 View of the slope, looking west, showing Baptiste Lake and mixed mature trees.
