**Re: Slope Stability Assessment – Proposed Residential Redevelopment,  
115 Rangers Road, Highland Grove, ON  
Cambium Reference: 22370-001**

**SLOPE STABILITY  
ASSESSMENT**  
JUSTIN AND NICOLE FLOWERDAY  
115 Rangers Road  
Highland Grove

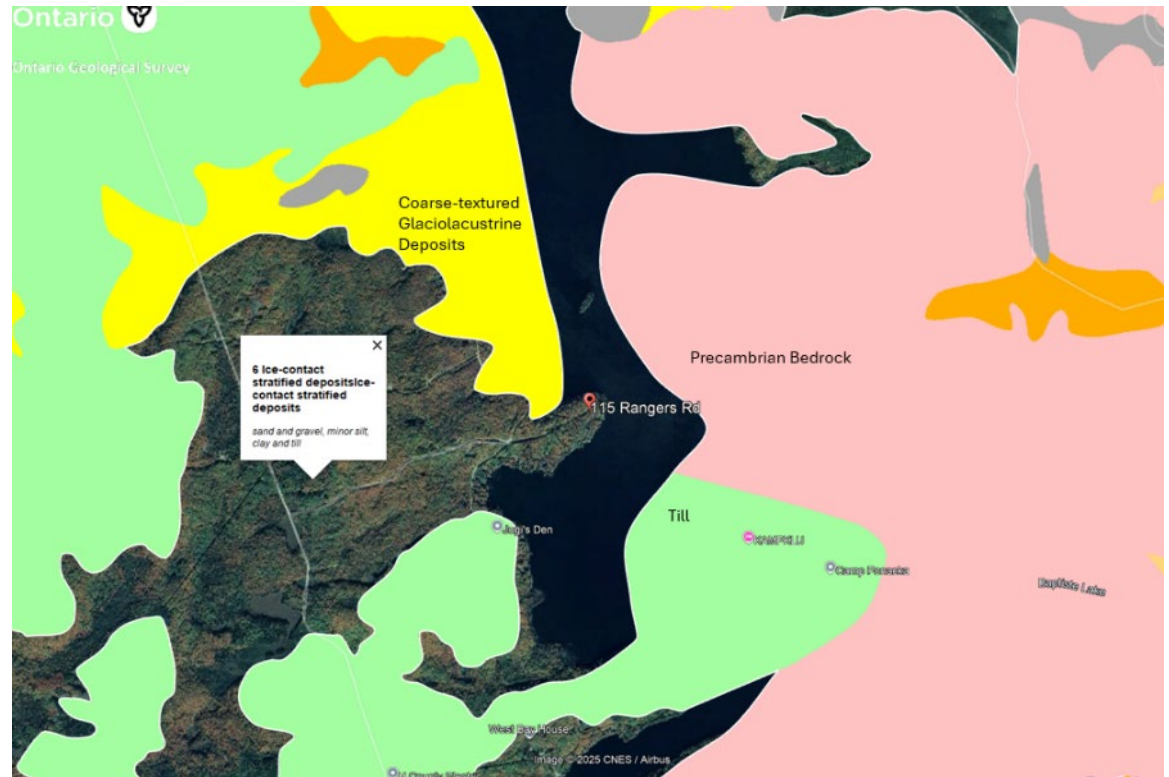
Based on MRD128-REV: Surficial Geology of Southern Ontario, the site is underlain by Ice-contact stratified deposits: sand and gravel, minor silt, clay and till on Precambrian terrain, Till: Silty sand to sand-textured till on Precambrian terrain, and Bedrock drift complex in Precambrian terrain as shown below.
